Access Compliance Report

Public Rights-of-Way

(Curb Ramps)

Intersection ID: 53964	Main Street: SPRING_SPRUCE_LN	Cross Street: MAGNOLIA_LILY_AV	Location: NW
ADA ID: C44D07374806	Ramp Type: Perp	Initial Pass/Fail: Fail	Overall Compliance: No
		Severity Score: 10

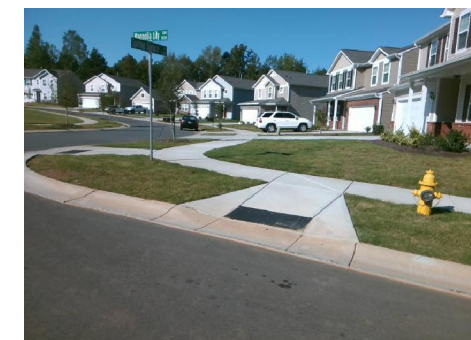
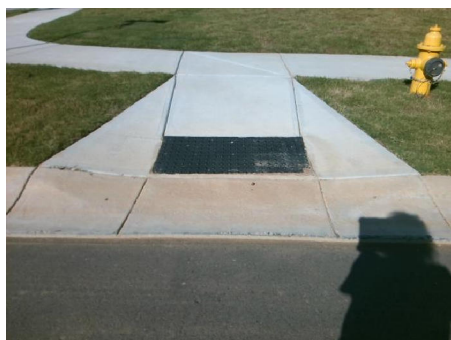
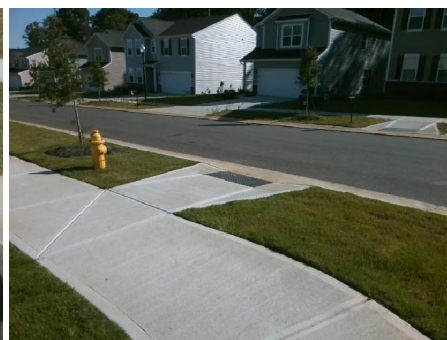
Not Found, R304.5.1

Compliance	Description	Data	Compliance	Description	Data
N/A	Ramp Length (in)	95.0	Yes	Ramp Slope (%)	7.6
No	Ramp Width (in)	47.0	Yes	Ramp XSlope (%)	2.2
N/A	Flare Type LT	N/A	N/A	Flare Type RT	N/A
N/A	Flare Slope LT (%)	N/A	N/A	Flare Slope RT (%)	N/A
N/A	Flare Traversable LT?	N/A	N/A	Flare Traversable RT?	N/A
N/A	Landing Length (in)	N/A	N/A	DWS Provided?	N/A
N/A	Landing Width (in)	N/A	N/A	DWS Contrast?	N/A
N/A	Landing Slope (%)	N/A	N/A	DWS Length (in)	N/A
N/A	Landing X Slope (%)	N/A	N/A	DWS Full Width?	N/A
N/A	Landing Curb? (Y/N)	N/A	N/A	DWS Offset (in)	N/A
N/A	Shared Landing?	N/A			
N/A	Gutter Ponding?	N/A	N/A	Gutter Slope (%)	N/A
N/A	Gutter Lip Ht (in)	1.5	N/A	Gutter X Slope (%)	N/A
N/A	Painted X Walk1?	No	N/A	Painted X Walk2?	N/A
	X Walk 1 Direction	To E		X Walk 2 Direction	N/A
N/A	X Walk 1 Width (in)	N/A	N/A	X Walk 2 Width (in)	N/A
	X Walk 1 Slope (%)	2.9		X Walk 2 Slope (%)	N/A
	X Walk 1 X Slope (%)	4.2		X Walk 2 X Slope (%)	N/A

Remove & Replace Entire Ramp.
