Access Compliance Report

Public Rights-of-Way

(Curb Ramps)

Intersection ID: 11331	Main Street: E_W_T_HARRIS_BV	Cross Street: MEADOW_ROSE_LN	Location: SW
ADA ID: C4509941815A	Ramp Type: Combination1	Initial Pass/Fail: Fail	Overall Compliance: No
		Severity Score: 30

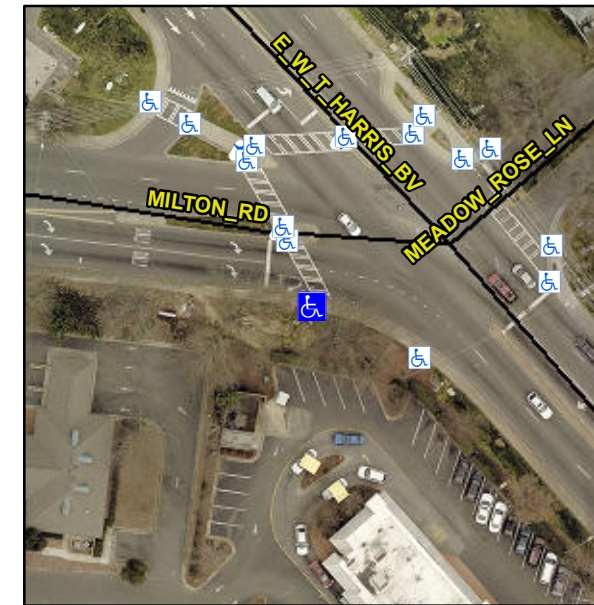
Not Found, R304.5.1, R304.5.3

Compliance	Description	Data	Compliance	Description	Data
N/A	Ramp Length LT (in)	73.0	N/A	Ramp Length RT (in)	70.5
No	Ramp Width LT (in)	35.0	No	Ramp Width RT (in)	35.5
Yes	Ramp Slope LT (%)	6.4	Yes	Ramp Slope RT (%)	6.4
No	Ramp XSlope LT (%)	5.3	No	Ramp XSlope RT (%)	2.7
N/A	Ramp Length (in)	25.0	Yes	Ramp Slope (%)	4.8
Yes	Ramp Width (in)	48.0	Yes	Ramp XSlope (%)	1.1
N/A	Flare Type LT	N/A	N/A	Flare Type RT	N/A
N/A	Flare Slope LT (%)	N/A	N/A	Flare Slope RT (%)	N/A
N/A	Flare Traversable LT?	N/A	N/A	Flare Traversable RT?	N/A
N/A	Landing Length (in)	N/A	N/A	DWS Provided?	N/A
N/A	Landing Width (in)	N/A	N/A	DWS Contrast?	N/A
N/A	Landing Slope (%)	N/A	N/A	DWS Length (in)	N/A
N/A	Landing X Slope (%)	N/A	N/A	DWS Full Width?	N/A
N/A	Landing Curb? (Y/N)	N/A	N/A	DWS Offset (in)	N/A
N/A	Shared Landing?	N/A			
N/A	Gutter Ponding?	N/A	N/A	Gutter Slope (%)	N/A
N/A	Gutter Lip Ht (in)	N/A	N/A	Gutter X Slope (%)	N/A
N/A	Painted X Walk1?	Yes	N/A	Painted X Walk2?	N/A

X Walk 1 Direction	To NW		X Walk 2 Direction	N/A
	X Walk 1 Width (in)	98.0		X Walk 2 Width (in)	N/A
	X Walk 1 Slope (%)	5.3		X Walk 2 Slope (%)	N/A
	X Walk 1 X Slope (%)	0.4		X Walk 2 X Slope (%)	N/A
N/A	Ramp inside XWalk1?	Yes	N/A	Ramp inside XWalk2?	N/A
	Road Slope (%)	N/A		Clear Space?	N/A
	Road X Slope (%)	N/A	N/A	Clear Space to XWalk (in)	N/A
			N/A	Any Obstruction?	N/A
				Obstruction Type	N/A
			N/A	Storm Grate/Utility Hazard?	N/A
				Storm Grate/Utility Type	N/A
					N/A
Yes	Surface Condition? (G/P)				Good
	Curb Slope (%)	7.1

Remove & Replace Entire Ramp.
