Access Compliance Report

Public Rights-of-Way (Curb Ramps)

Intersection ID: 10018791	Main Street: BENGALI_CR	Cross Street: N/A	Location: SW
ADA ID: C450A461F472	Ramp Type: Perp	Initial Pass/Fail: Fail	Overall Compliance: No
Severity Score: 8.75			
Codes/Mitigation Info/Possible Solution		Field Measurements/Component Compliance

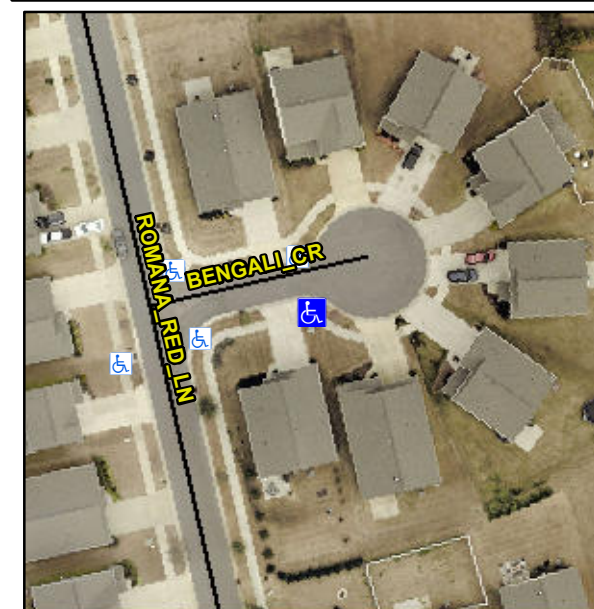
Not Found, R304.5.1

Compliance	Description	Data	Compliance	Description	Data
N/A	Ramp Length (in)	71.0	Yes	Ramp Slope (%)	6.2
No	Ramp Width (in)	47.5	Yes	Ramp XSlope (%)	2.0
N/A	Flare Type LT	N/A	N/A	Flare Type RT	N/A
N/A	Flare Slope LT (%)	N/A	N/A	Flare Slope RT (%)	N/A
N/A	Flare Traversable LT?	N/A	N/A	Flare Traversable RT?	N/A
N/A	Landing Length (in)	N/A	N/A	DWS Provided?	N/A
N/A	Landing Width (in)	N/A	N/A	DWS Contrast?	N/A
N/A	Landing Slope (%)	N/A	N/A	DWS Length (in)	N/A
N/A	Landing X Slope (%)	N/A	N/A	DWS Full Width?	N/A
N/A	Landing Curb? (Y/N)	N/A	N/A	DWS Offset (in)	N/A
N/A	Shared Landing?	N/A			
N/A	Gutter Ponding?	N/A	N/A	Gutter Slope (%)	N/A
N/A	Gutter Lip Ht (in)	N/A	N/A	Gutter X Slope (%)	N/A
N/A	Painted X Walk1?	No	N/A	Painted X Walk2?	N/A
	X Walk 1 Direction	To N		X Walk 2 Direction	N/A
N/A	X Walk 1 Width (in)	N/A	N/A	X Walk 2 Width (in)	N/A
	X Walk 1 Slope (%)	3.7		X Walk 2 Slope (%)	N/A
	X Walk 1 X Slope (%)	2.2		X Walk 2 X Slope (%)	N/A

Possible Solutions:

Remove & Replace Entire Ramp.

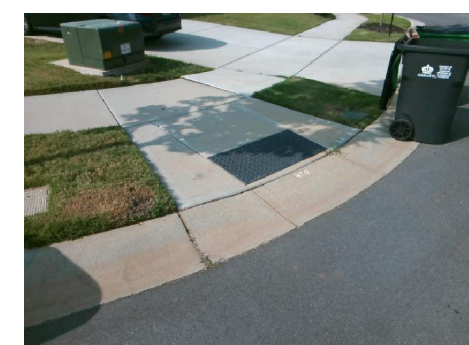
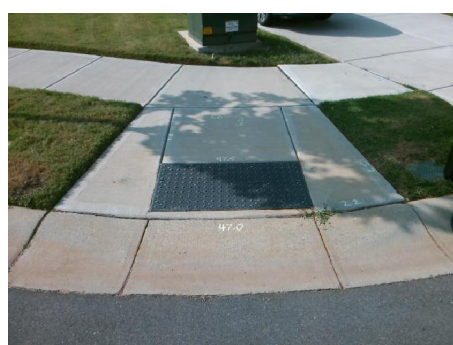
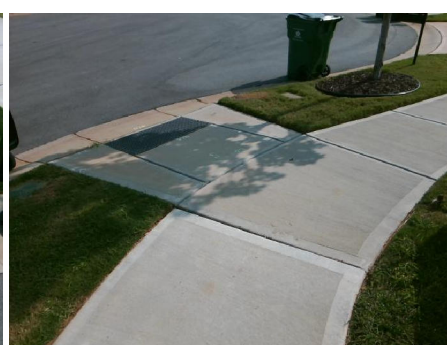
N/A	Ramp inside XWalk1?	N/A	N/A	Ramp inside XWalk2?	N/A
	Road Slope (%)	N/A	N/A	Clear Space?	N/A
	Road X Slope (%)	N/A	N/A	Clear Space to XWalk (in)	N/A
N/A	Any Obstructions?	N/A	N/A	Storm Grate/Utility Hazard?	N/A
	Obstruction Type			Storm Grate/Utility Type	
		N/A			N/A
			Yes	Surface Condition? (G/P)	Good
