Access Compliance Report

Public Rights-of-Way

(Curb Ramps)

Intersection ID: 12240	Main Street: ALLEN_ST	Cross Street: E_15TH_ST	Location: S
ADA ID: C455EF93D227	Ramp Type: BlendTrans1	Initial Pass/Fail: Fail	Overall Compliance: No
		Severity Score: 8.75

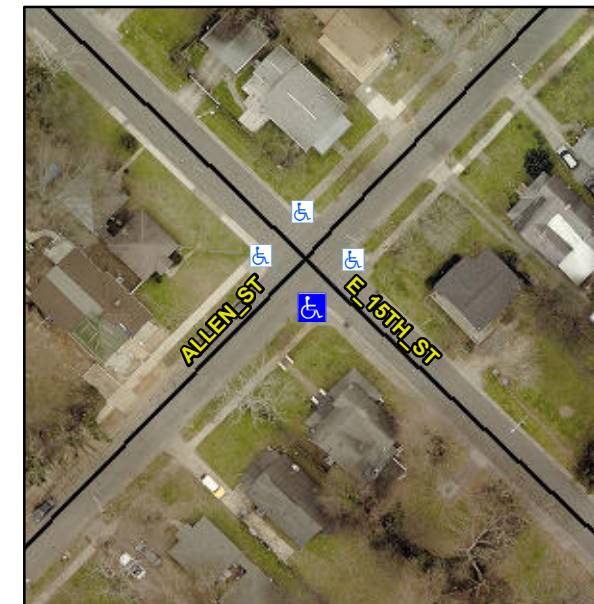
Compliance	Description	Data	Compliance	Description	Data
N/A	Ramp Length (in)	65.0	Yes	BlendTrans Slope (%)	4.3
No	Ramp Width (in)	42.0	Yes	BlendTrans XSlope (%)	0.8
N/A	Flare Type LT	N/A	N/A	Flare Type RT	N/A
N/A	Flare Slope LT (%)	N/A	N/A	Flare Slope RT (%)	N/A
N/A	Flare Traversable LT?	N/A	N/A	Flare Traversable RT?	N/A
N/A	Landing Length (in)	N/A	N/A	DWS Provided?	N/A
N/A	Landing Width (in)	N/A	N/A	DWS Contrast?	N/A
N/A	Landing Slope (%)	N/A	N/A	DWS Length (in)	N/A
N/A	Landing X Slope (%)	N/A	N/A	DWS Full Width?	N/A
N/A	Landing Curb? (Y/N)	N/A	N/A	DWS Offset (in)	N/A
N/A	Shared Landing?	N/A			
N/A	Gutter Ponding?	N/A	N/A	Gutter Slope (%)	N/A
N/A	Gutter Lip Ht (in)	N/A	N/A	Gutter X Slope (%)	N/A
N/A	Painted X Walk1?	No	N/A	Painted X Walk2?	No
	X Walk 1 Direction	To NE		X Walk 2 Direction	To NW
	X Walk 1 Width (in)	N/A		X Walk 2 Width (in)	N/A
	X Walk 1 Slope (%)	3.7		X Walk 2 Slope (%)	2.2
	X Walk 1 X Slope (%)	2.7		X Walk 2 X Slope (%)	2.0

N/A	Ramp inside XWalk1?	N/A	N/A	Ramp inside XWalk2?	N/A
	Road Slope (%)	5.7		Clear Space?	N/A
	Road X Slope (%)	3.7	N/A	Clear Space to XWalk (in)	N/A
N/A	Any Obstructions?	N/A	N/A	Storm Grate/Utility Hazard?	N/A
	Obstruction Type			Storm Grate/Utility Type	
		N/A			N/A
			Yes	Surface Condition? (G/P)	Good
			No	Curb Slope (%)	19.1

Remove & Replace Curb Ramp With Two New Directional Ramps or Equivalent.

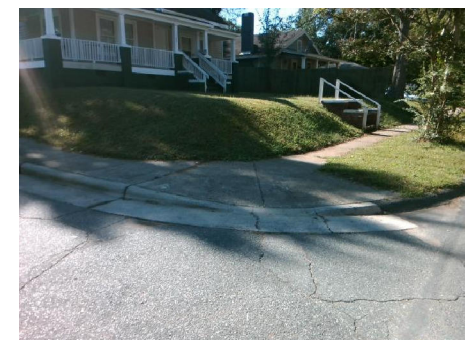
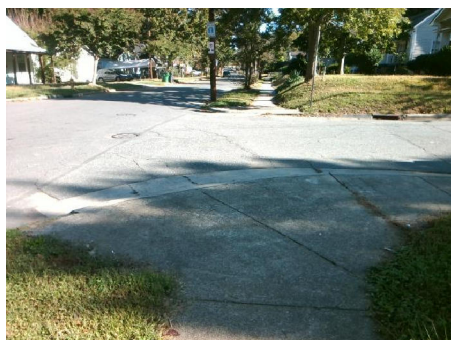
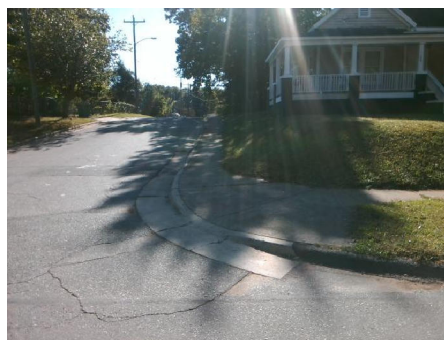
Street 1 Name E 15TH ST
 Stop Condition-Street 1 StopSign
 Street 2 Name ALLEN ST
 Stop Condition-Street 2 None
