# Access Compliance Report

## Public Rights-of-Way

### (Curb Ramps)

Intersection ID: 50903	Main Street: HELENA_PARK_LN	Cross Street: KNOX_AV	Location: S
ADA ID: C459E8B5CF98	Ramp Type: Perp	Initial Pass/Fail: Fail	Overall Compliance: No
Codes/Mitigation Info/Possible Solution			Severity Score: 10
			Field Measurements/Component Compliance

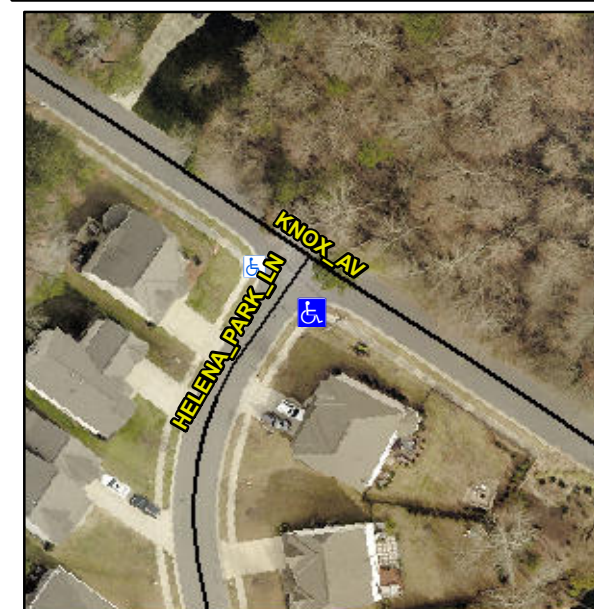
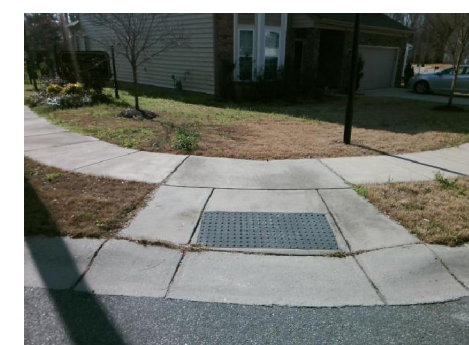
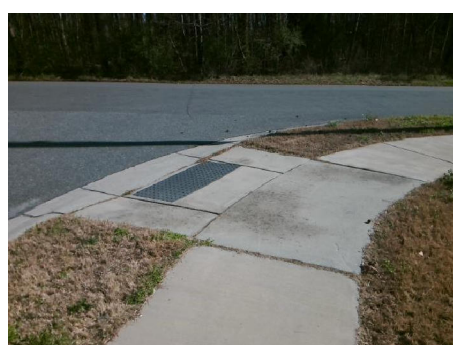
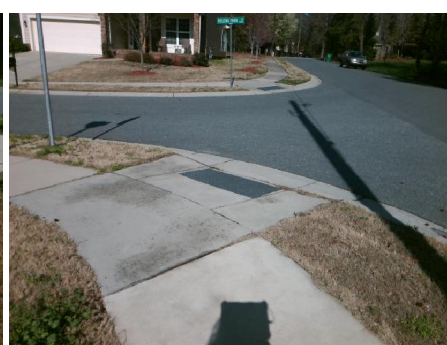
Compliance	Description	Data	Compliance	Description	Data
N/A	Ramp Length (in)	49.0	Yes	Ramp Slope (%)	7.1
No	Ramp Width (in)	47.0	No	Ramp XSlope (%)	2.1
N/A	Flare Type LT	N/A	N/A	Flare Type RT	N/A
N/A	Flare Slope LT (%)	N/A	N/A	Flare Slope RT (%)	N/A
N/A	Flare Traversable LT?	N/A	N/A	Flare Traversable RT?	N/A
N/A	Landing Length (in)	N/A	N/A	DWS Provided?	N/A
N/A	Landing Width (in)	N/A	N/A	DWS Contrast?	N/A
N/A	Landing Slope (%)	N/A	N/A	DWS Length (in)	N/A
N/A	Landing X Slope (%)	N/A	N/A	DWS Full Width?	N/A
N/A	Landing Curb? (Y/N)	N/A	N/A	DWS Offset (in)	N/A
N/A	Shared Landing?	N/A			
N/A	Gutter Ponding?	N/A	N/A	Gutter Slope (%)	N/A
N/A	Gutter Lip Ht (in)	N/A	N/A	Gutter X Slope (%)	N/A
N/A	Painted X Walk1?	No	N/A	Painted X Walk2?	N/A
	X Walk 1 Direction	To NW		X Walk 2 Direction	N/A
N/A	X Walk 1 Width (in)	N/A	N/A	X Walk 2 Width (in)	N/A
	X Walk 1 Slope (%)	3.6		X Walk 2 Slope (%)	N/A
	X Walk 1 X Slope (%)	5.2		X Walk 2 X Slope (%)	N/A

N/A	Ramp inside XWalk1?	N/A	N/A	Ramp inside XWalk2?	N/A
	Road Slope (%)	N/A	N/A	Clear Space?	N/A
	Road X Slope (%)	N/A	N/A	Clear Space to XWalk (in)	N/A
N/A	Any Obstructions?	N/A	N/A	Storm Grate/Utility Hazard?	N/A
	Obstruction Type			Storm Grate/Utility Type	
		N/A			N/A
			Yes	Surface Condition? (G/P)	Good

**Remove & Replace Entire Ramp.**

**R304.5.1, R304.5.3**
