Access Compliance Report

Public Rights-of-Way (Curb Ramps)

Intersection ID: 48433	Main Street: WHITHORN_WY	Cross Street: SEAMILL_RD	Location: SW
ADA ID: C45F7E050FEC	Ramp Type: PerpDiag	Initial Pass/Fail: Fail	Overall Compliance: No
Severity Score: 25			
Codes/Mitigation Info/Possible Solution		Field Measurements/Component Compliance

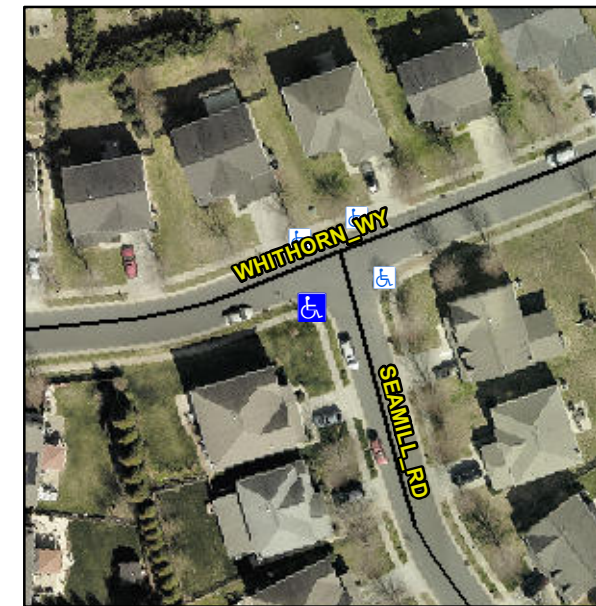
R304.2.2, R304.5.3

Compliance	Description	Data	Compliance	Description	Data
N/A	Ramp Length (in)	47.0	No	Ramp Slope (%)	10.7
Yes	Ramp Width (in)	48.0	No	Ramp XSlope (%)	5.9
N/A	Flare Type LT	N/A	N/A	Flare Type RT	N/A
N/A	Flare Slope LT (%)	N/A	N/A	Flare Slope RT (%)	N/A
N/A	Flare Traversable LT?	N/A	N/A	Flare Traversable RT?	N/A
N/A	Landing Length (in)	N/A	N/A	DWS Provided?	N/A
N/A	Landing Width (in)	N/A	N/A	DWS Contrast?	N/A
N/A	Landing Slope (%)	N/A	N/A	DWS Length (in)	N/A
N/A	Landing X Slope (%)	N/A	N/A	DWS Full Width?	N/A
N/A	Landing Curb? (Y/N)	N/A	N/A	DWS Offset (in)	N/A
N/A	Shared Landing?	N/A			
N/A	Gutter Ponding?	N/A	N/A	Gutter Slope (%)	N/A
N/A	Gutter Lip Ht (in)	N/A	N/A	Gutter X Slope (%)	N/A
N/A	Painted X Walk1?	No	N/A	Painted X Walk2?	No
	X Walk 1 Direction	To E		X Walk 2 Direction	To N
N/A	X Walk 1 Width (in)	N/A	N/A	X Walk 2 Width (in)	N/A
	X Walk 1 Slope (%)	2.7		X Walk 2 Slope (%)	0.9
	X Walk 1 X Slope (%)	0.3		X Walk 2 X Slope (%)	3.8

N/A	Ramp inside XWalk1?	N/A	N/A	Ramp inside XWalk2?	N/A
	Road Slope (%)	2.8	N/A	Clear Space?	N/A
	Road X Slope (%)	4.0	N/A	Clear Space to XWalk (in)	N/A
N/A	Any Obstructions?	N/A	N/A	Storm Grate/Utility Hazard?	N/A
	Obstruction Type			Storm Grate/Utility Type	
		N/A			N/A
		Yes		Surface Condition? (G/P)	Good

Remove & Replace Curb Ramp With Two New Directional Ramps or Equivalent.

Total Cost: \$ 3200.00
