# Access Compliance Report

## Public Rights-of-Way

| Intersection ID: 42494 | Main Street: BULLOCK_GREENWAY_BV | Cross Street: TOLLESON_AV | Location: SE |
| ADA ID: C466EF7FA975 | Ramp Type: PerpDiag | Initial Pass/Fail: Fail | Overall Compliance: No |

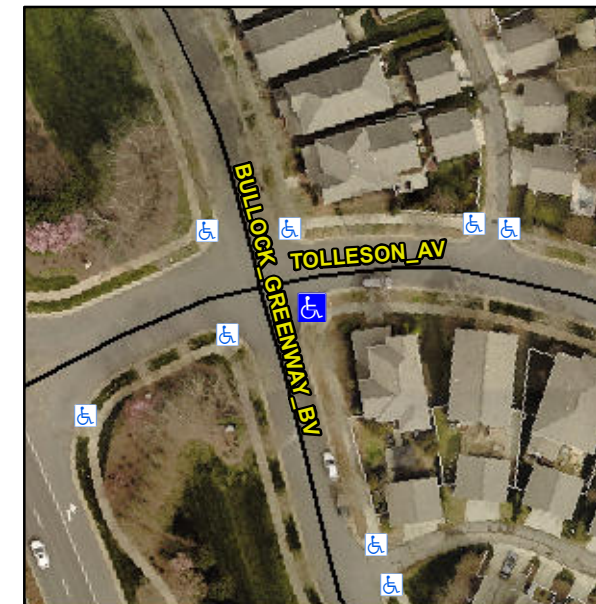
| Severity Score: 8.75 | | | |

**Not Found, R304.5.1**

| Compliance | Description | Data | Compliance | Description | Data |
|---|---|---|---|---|---|
| No | Ramp Width (in) | 44.0 | Yes | Ramp XSlope (%) | 1.3 |

**Remove & Replace Curb Ramp With Two New Directional Ramps or Equivalent.**
