Access Compliance Report

Public Rights-of-Way

(Curb Ramps)

| Intersection ID: 52590 | Main Street: NOBLES_AV | Cross Street: TRIUMPH_DR | Location: NE |

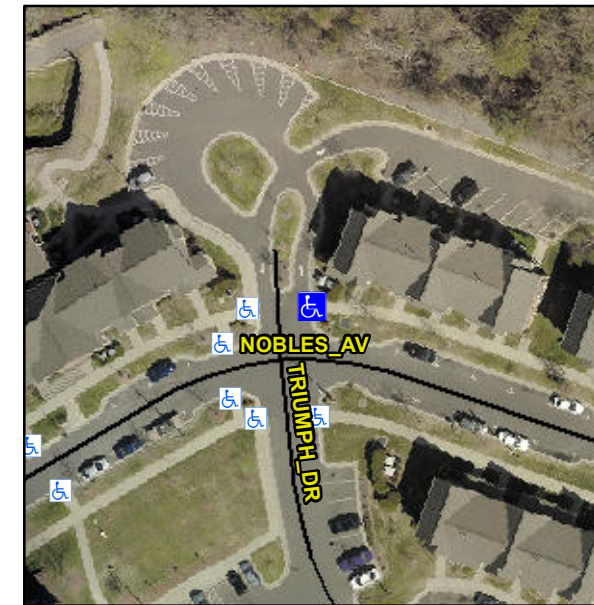
| ADA ID: C47111C993C8 | Ramp Type: Perp | Initial Pass/Fail: Fail | Overall Compliance: No |

Not Found, R304.2.2

| Compliance | Description | Data | Compliance | Description | Data |
|---|---|---|---|---|---|
| N/A | Ramp Length (in) | 62.0 | No | Ramp Slope (%) | 9.1 |

Remove & Replace Entire Ramp.
