Access Compliance Report

Public Rights-of-Way

(Curb Ramps)

Intersection ID: 2864	Main Street: ROCK_STREAM_DR	Cross Street: WAVERLY_LYNN_LN	Location:	N
ADA ID: C47CA56E8F11	Ramp Type: Perp	Initial Pass/Fail: Fail	Overall Compliance: No	Severity Score: 10
Codes/Mitigation Info/Possible Solution		Field Measurements/Component Compliance

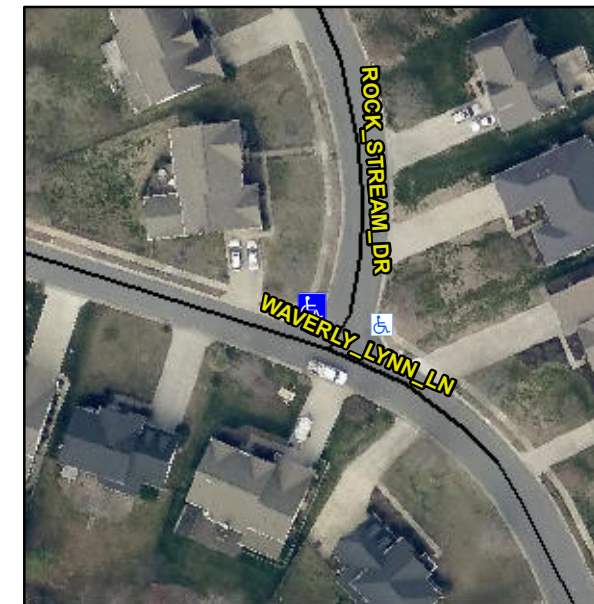
Not Found, R304.5.1, R304.5.3

Compliance	Description	Data	Compliance	Description	Data
N/A	Ramp Length (in)	48.0	Yes	Ramp Slope (%)	7.4
No	Ramp Width (in)	40.0	No	Ramp XSlope (%)	2.2
N/A	Flare Type LT	N/A	N/A	Flare Type RT	N/A
N/A	Flare Slope LT (%)	N/A	N/A	Flare Slope RT (%)	N/A
N/A	Flare Traversable LT?	N/A	N/A	Flare Traversable RT?	N/A
N/A	Landing Length (in)	N/A	N/A	DWS Provided?	N/A
N/A	Landing Width (in)	N/A	N/A	DWS Contrast?	N/A
N/A	Landing Slope (%)	N/A	N/A	DWS Length (in)	N/A
N/A	Landing X Slope (%)	N/A	N/A	DWS Full Width?	N/A
N/A	Landing Curb? (Y/N)	N/A	N/A	DWS Offset (in)	N/A
N/A	Shared Landing?	N/A			
N/A	Gutter Ponding?	N/A	N/A	Gutter Slope (%)	N/A
N/A	Gutter Lip Ht (in)	N/A	N/A	Gutter X Slope (%)	N/A
N/A	Painted X Walk1?	No	N/A	Painted X Walk2?	N/A
	X Walk 1 Direction	To SE		X Walk 2 Direction	N/A
N/A	X Walk 1 Width (in)	N/A	N/A	X Walk 2 Width (in)	N/A
	X Walk 1 Slope (%)	5.4		X Walk 2 Slope (%)	N/A
	X Walk 1 X Slope (%)	3.6		X Walk 2 X Slope (%)	N/A

N/A	Ramp inside XWalk1?	N/A	N/A	Ramp inside XWalk2?	N/A
	Road Slope (%)	N/A	N/A	Clear Space?	N/A
	Road X Slope (%)	N/A	N/A	Clear Space to XWalk (in)	N/A
N/A	Any Obstructions?	N/A	N/A	Storm Grate/Utility Hazard?	N/A
	Obstruction Type			Storm Grate/Utility Type	
		N/A			N/A
			Yes	Surface Condition? (G/P)	Good

Possible Solutions:

Remove & Replace Entire Ramp.
