# Access Compliance Report

## Public Rights-of-Way

### (Curb Ramps)

Intersection ID: 48140	Main Street: MCCAMEY_DR	Cross Street: BUTTERBURR_DR	Location: SE
ADA ID: C47CAD7F2377	Ramp Type: PerpDiag	Initial Pass/Fail: Fail	Overall Compliance: No
Severity Score: 8.75			
Codes/Mitigation Info/Possible Solution		Field Measurements/Component Compliance

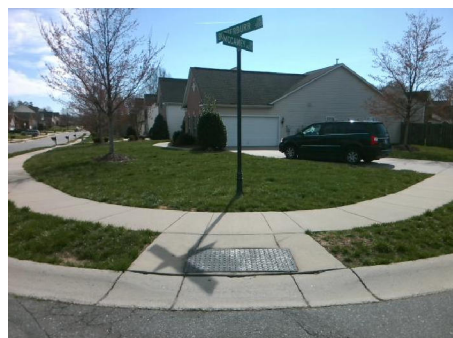
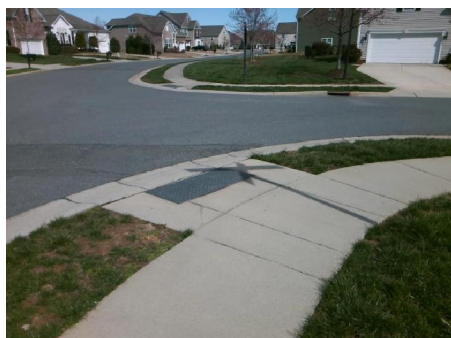
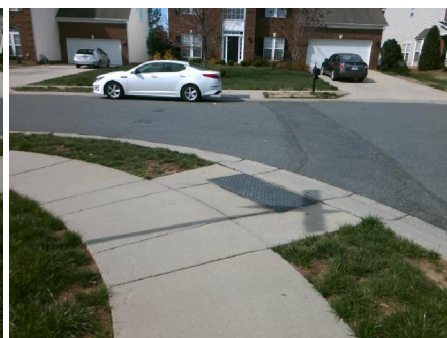
Compliance	Description	Data	Compliance	Description	Data
N/A	Ramp Length (in)	48.0	Yes	Ramp Slope (%)	5.2
No	Ramp Width (in)	38.0	Yes	Ramp XSlope (%)	0.3
N/A	Flare Type LT	N/A	N/A	Flare Type RT	N/A
N/A	Flare Slope LT (%)	N/A	N/A	Flare Slope RT (%)	N/A
N/A	Flare Traversable LT?	N/A	N/A	Flare Traversable RT?	N/A
N/A	Landing Length (in)	N/A	N/A	DWS Provided?	N/A
N/A	Landing Width (in)	N/A	N/A	DWS Contrast?	N/A
N/A	Landing Slope (%)	N/A	N/A	DWS Length (in)	N/A
N/A	Landing X Slope (%)	N/A	N/A	DWS Full Width?	N/A
N/A	Landing Curb? (Y/N)	N/A	N/A	DWS Offset (in)	N/A
N/A	Shared Landing?	N/A			
N/A	Gutter Ponding?	N/A	N/A	Gutter Slope (%)	N/A
N/A	Gutter Lip Ht (in)	N/A	N/A	Gutter X Slope (%)	N/A
N/A	Painted X Walk1?	No	N/A	Painted X Walk2?	No
	X Walk 1 Direction	To N		X Walk 2 Direction	To W
N/A	X Walk 1 Width (in)	N/A	N/A	X Walk 2 Width (in)	N/A
	X Walk 1 Slope (%)	3.6		X Walk 2 Slope (%)	2.2
	X Walk 1 X Slope (%)	1.1		X Walk 2 X Slope (%)	1.5

N/A	Ramp inside XWalk1?	N/A	N/A	Ramp inside XWalk2?	N/A
	Road Slope (%)	1.3	N/A	Clear Space?	N/A
	Road X Slope (%)	2.7	N/A	Clear Space to XWalk (in)	N/A
N/A	Any Obstructions?	N/A	N/A	Storm Grate/Utility Hazard?	N/A
	Obstruction Type			Storm Grate/Utility Type	
		N/A			N/A
			Yes	Surface Condition? (G/P)	Good

**Remove & Replace Curb Ramp With Two New Directional Ramps or Equivalent.**

Total Cost: \$ 3200.00
