Access Compliance Report

Public Rights-of-Way

(Curb Ramps)

Intersection ID: 48584	Main Street: TREEFROG_CT	Cross Street: WATERLILY_LN	Location: S
ADA ID: C47EC425C5FE	Ramp Type: Perp	Initial Pass/Fail: Pass	Overall Compliance: No
Severity Score: 5			
Codes/Mitigation Info/Possible Solution		Field Measurements/Component Compliance

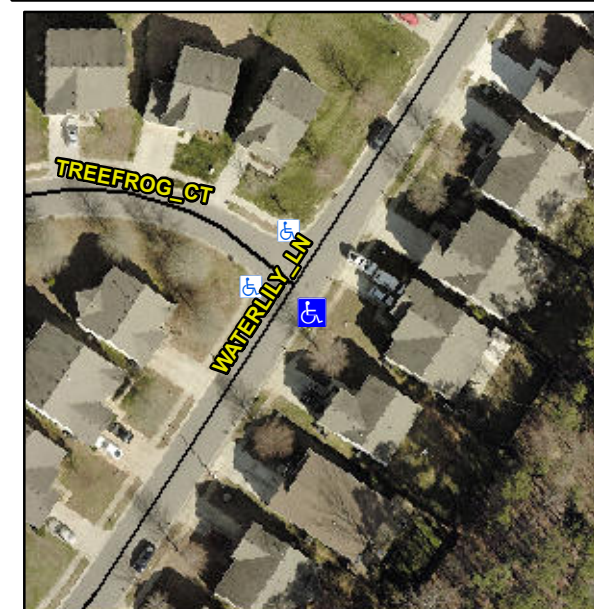
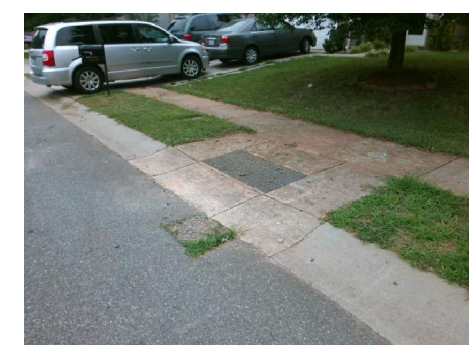
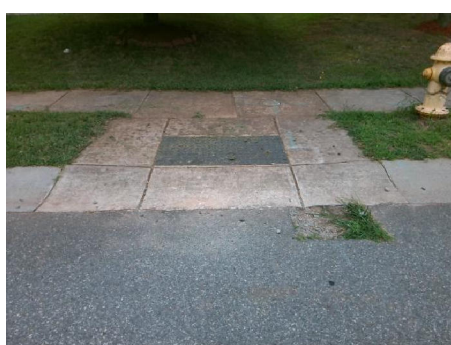
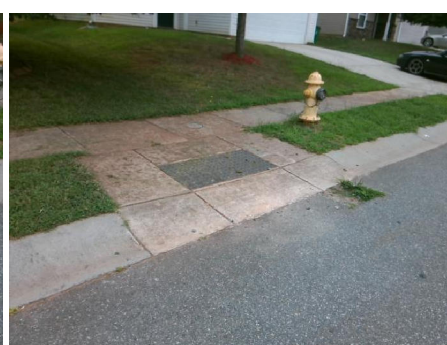
Not Found, R304.5.4

Compliance	Description	Data	Compliance	Description	Data
N/A	Ramp Length (in)	48.0	Yes	Ramp Slope (%)	5.4
Yes	Ramp Width (in)	48.0	Yes	Ramp XSlope (%)	1.6
N/A	Flare Type LT	Sloped	N/A	Flare Type RT	N/A
N/A	Flare Slope LT (%)	1.9	N/A	Flare Slope RT (%)	6.4
N/A	Flare Traversable LT?	No	N/A	Flare Traversable RT?	No
Yes	Landing Length (in)	48.0	Yes	DWS Provided?	Yes
Yes	Landing Width (in)	48.0	Yes	DWS Contrast?	Yes
Yes	Landing Slope (%)	0.5	Yes	DWS Length (in)	24.0
Yes	Landing X Slope (%)	0.3	Yes	DWS Full Width?	Yes
N/A	Landing Curb? (Y/N)	No	Yes	DWS Offset (in)	1.5
N/A	Shared Landing?	No			
Yes	Gutter Ponding?	No	No	Gutter Slope (%)	6.5
Yes	Gutter Lip Ht (in)	0.0	Yes	Gutter X Slope (%)	1.8
N/A	Painted X Walk1?	No	N/A	Painted X Walk2?	N/A
	X Walk 1 Direction	To NW		X Walk 2 Direction	N/A
N/A	X Walk 1 Width (in)	N/A	N/A	X Walk 2 Width (in)	N/A
	X Walk 1 Slope (%)	2.1		X Walk 2 Slope (%)	N/A
	X Walk 1 X Slope (%)	0.6		X Walk 2 X Slope (%)	N/A

N/A	Ramp inside XWalk1?	N/A	N/A	Ramp inside XWalk2?	N/A
	Road Slope (%)	N/A	N/A	Clear Space?	Yes
	Road X Slope (%)	N/A	N/A	Clear Space to XWalk (in)	N/A
Yes	Any Obstructions?	No	Yes	Storm Grate/Utility Hazard?	No
	Obstruction Type			Storm Grate/Utility Type	
		N/A			N/A
			Yes	Surface Condition? (G/P)	Good

**Remove & Replace Entire Ramp.
Remove & Replace Gutter.**

Total Cost: \$ 2600.00
