# Access Compliance Report

## Public Rights-of-Way

| Intersection ID: 51704 | Main Street: IKEA_BV | Cross Street: BROOKSIDE_LN | Location: SW |
| ADA ID: C4865909F210 | Ramp Type: Perp | Initial Pass/Fail: Fail | Overall Compliance: No |

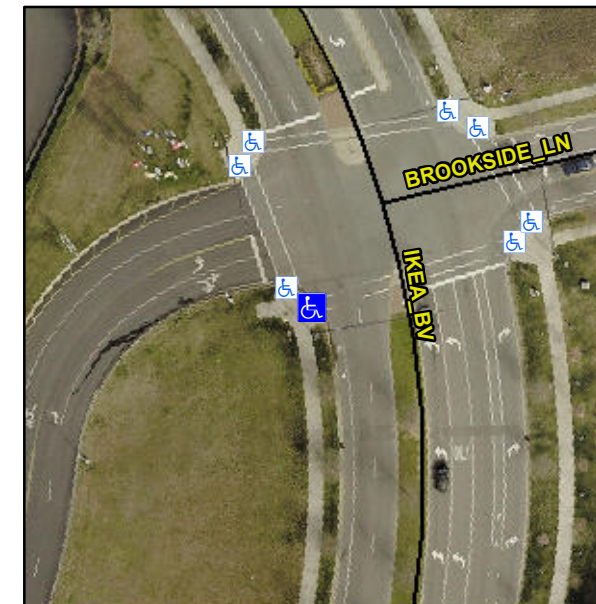
| Severity Score: 10 | | | |

**Not Found, R304.5.1, R304.5.3**

| Compliance | Description | Data | Compliance | Description | Data |
|---|---|---|---|---|---|
| N/A | Ramp Length (in) | 96.0 | Yes | Ramp Slope (%) | 6.5 |
| No | Ramp Width (in) | 47.5 | No | Ramp XSlope (%) | 3.4 |

**Remove & Replace Entire Ramp.**

Total Cost: \$ 1850.00
