Access Compliance Report

Public Rights-of-Way

(Curb Ramps)

Intersection ID: 11659	Main Street: E_16TH_ST	Cross Street: N_DAVIDSON_ST	Location: E
ADA ID: C48690EDA0BB	Ramp Type: PerpDiag	Initial Pass/Fail: Fail	Overall Compliance: No
			Severity Score: 33.75

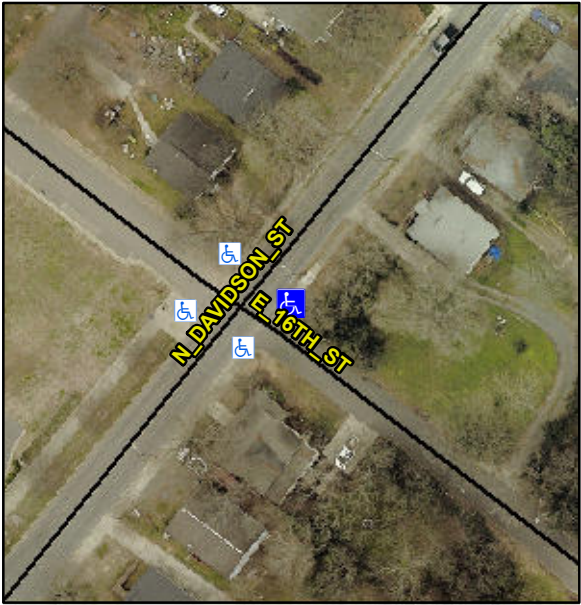
Possible Solutions:	Compliance	Description	Data	Compliance
	Remove & Replace Curb Ramp With Two New Directional Ramps or Equivalent.	No	Ramp Length (in)	59.0	No
		No	Ramp Width (in)	43.0	No
		N/A	Flare Type LT	N/A	N/A
		N/A	Flare Slope LT (%)	N/A	N/A
		N/A	Flare Traversable LT?	N/A	N/A
		N/A	Landing Length (in)	N/A	N/A
		N/A	Landing Width (in)	N/A	N/A
		N/A	Landing Slope (%)	N/A	N/A
		N/A	Landing X Slope (%)	N/A	N/A
<p>Surveyor Notes:</p> <p>N/A</p> <p>PROW/ADA:</p> <p>Not Found, R304.5.1, R304.2.2, R304.5.3</p>		N/A	Flare Type RT	N/A	N/A
		N/A	Flare Slope RT (%)	N/A	N/A
		N/A	Flare Traversable RT?	N/A	N/A
		N/A	DWS Provided?	N/A	N/A
		N/A	DWS Contrast?	N/A	N/A
		N/A	DWS Length (in)	N/A	N/A
		N/A	DWS Full Width?	N/A	N/A
		N/A	DWS Offset (in)	N/A	N/A
		N/A	Gutter Ponding?	N/A	N/A
		N/A	Gutter Lip Ht (in)	N/A	N/A
<p>Total Cost:</p> <p>\$ 3200.00</p>		No	Painted X Walk1?	No	N/A

N/A	X Walk 1 Direction	To NW	N/A
		N/A	X Walk 1 Width (in)	N/A	N/A
		N/A	X Walk 1 Slope (%)	4.8	N/A
		N/A	X Walk 1 X Slope (%)	0.3	N/A
		N/A	Ramp inside XWalk1?	N/A	N/A
		N/A	Road Slope (%)	2.8	N/A
		N/A	Road X Slope (%)	4.6	N/A
		N/A	Any Obstructions?	N/A	N/A
		N/A	Obstruction Type		N/A
		N/A	Storm Grate/Utility Hazard?	N/A	N/A
		N/A	Storm Grate/Utility Type		N/A
		Yes	Surface Condition? (G/P)	Good	Good
