Access Compliance Report Public Rights-of-Way (Curb Ramps)

Intersection ID: 49315 Main Street: ANNA_JORDAN_DR **Cross Street: ROCKLAND DR** Location: Ε **Overall Compliance: No** ADA ID: C4874E73646E Ramp Type: Perp Initial Pass/Fail: Fail **Severity Score:** 25

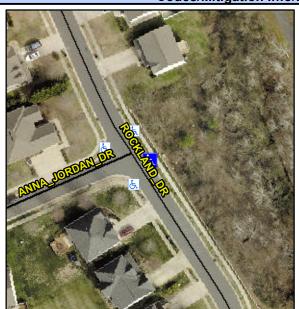
9.0

5.4

Ramp Slope (%)

Ramp XSlope (%)

Possible Solutions:	Comp	liance	Description
Remove & Replace Entire Ramp.	N/A	Ram	c Length (in)
·	Yes	Ram	o Width (in)
	N/A	Flare	Type LT
	N/A	Flare	Slope LT (%)
	N/A	Flare	Traversable L1
	N/A	Land	ing Length (in)
Surveyor Notes:	N/A	Land	ing Width (in)
N/A	N/A	Land	ing Slope (%)
	N/A	Land	ing X Slope (%
	N/A	Land	ing Curb? (Y/N
	N/A	Share	ed Landing?
PROW/ADA:	N/A	Gutte	er Ponding?
Not Found, R304.2.2, R304.5.3	N/A	Gutte	er Lip Ht (in)
	N/A	Paint	ed X Walk1?
		X Wa	lk 1 Direction
	N/A	X Wa	ılk 1 Width (in)
		X Wa	lk 1 Slope (%)
		X Wa	lk 1 X Slope (%
	N/A	Ram	o inside XWalk
		Road	Slope (%)
