Access Compliance Report

Public Rights-of-Way

(Curb Ramps)

Intersection ID: 17651		Main Street: CHELSEA_DR		Cross Street: HILLSIDE_AV		Location: SW											
ADA ID: C488ED1A8906		Ramp Type: Directional1		Initial Pass/Fail: Fail		Overall Compliance: No		Severity Score: 12.5									
Codes/Mitigation Info/Possible Solution				Field Measurements/Component Compliance													
<div>

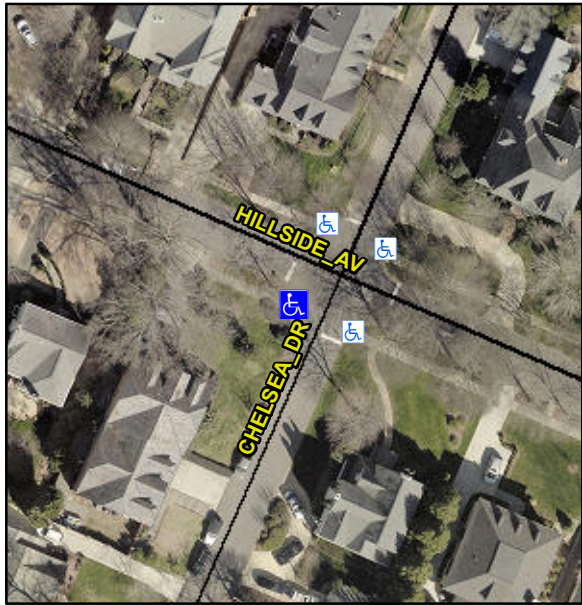
</div> <div>Possible Solutions:</div> <div>Remove & Replace Entire Ramp.</div> <div>Surveyor Notes:</div> <div>ASP LIP 1.0"</div> <div>PROW/ADA:</div> <div>R304.2.2</div> <div>Street 1 NameCHELSEA DR</div> <div>Stop Condition-Street 1StopSign</div> <div>Street 2 NameN/A</div> <div>Stop Condition-Street 2N/A</div> <div>Total Cost:\$1600.00</div>				Compliance		Description		Data		Compliance		Description		Data			
				N/A		Ramp Length (in)		94.0		N/A		Grade Break?		N/A		N/A	
				Yes		Ramp Width (in)		54.0		N/A		Grade Break Slope (%)		0.0		0.0	
				No		Ramp Slope (%)		8.5		N/A		Grade Break XSlope (%)		0.0		0.0

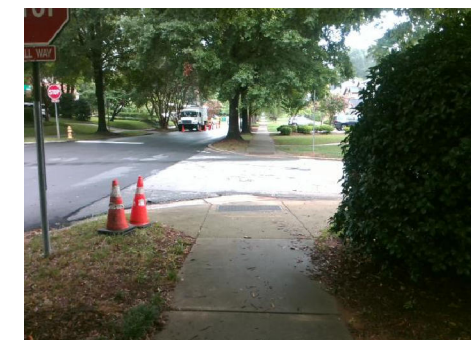
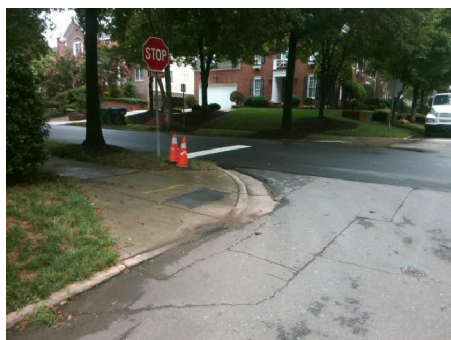
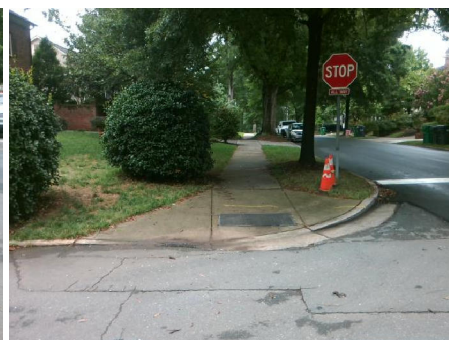
Yes		Ramp XSlope (%)		1.7									
				N/A		Flare Type LT		N/A		N/A		Flare Type RT		N/A		N/A	
				N/A		Flare Slope LT (%)		N/A		N/A		Flare Slope RT (%)		0.0		0.0	
				N/A		Flare Traversable LT?		N/A		N/A		Flare Traversable RT?		N/A		N/A	
				N/A		Landing Length (in)		0.0		N/A		DWS Provided?		N/A		N/A	
				N/A		Landing Width (in)		0.0		N/A		DWS Contrast?		N/A		N/A	
				N/A		Landing Slope (%)		0.0		N/A		DWS Length (in)		N/A		N/A	
				N/A		Landing X Slope (%)		0.0		N/A		DWS Full Width?		N/A		N/A	
				N/A		Landing Curb? (Y/N)		N/A		N/A		DWS Offset LT (in)		N/A		N/A	
				N/A		Shared Landing?		N/A		N/A		DWS Offset RT (in)		N/A		N/A	
				N/A		Gutter Ponding?		0.0		N/A		Gutter Slope (%)		N/A		N/A	
				N/A		Gutter Lip Ht (in)		0.0		N/A		Gutter X Slope (%)		N/A		N/A	
				N/A		Painted X Walk1?		No				Road Slope (%)		0.4		0.4	
						X Walk 1 Direction		To E				Road X Slope (%)		4.3		4.3	
						X Walk 1 Width (in)		N/A				Clear Space?		N/A		N/A

X Walk 1 Slope (%)		0.4		N/A		Clear Space to XWalk (in)		N/A		N/A	
						X Walk 1 X Slope (%)		4.3		N/A		Storm Grate/Utility Hazard?		N/A		N/A	
				N/A		Ramp inside XWalk1?		N/A				Storm Grate/Utility Type					
				N/A		Any Obstructions?		N/A						N/A		N/A	
						Obstruction Type				Yes		Surface Condition? (G/P)		Good		Good	
										N/A		N/A		Curb Slope (%)		9.4
