Access Compliance Report

Public Rights-of-Way

(Curb Ramps)

Intersection ID: N/A	Main Street: E_TRADE_ST	Cross Street: S_BREVARD_ST	Location: SE
ADA ID: C48B56BCFBCF	Ramp Type: Perp	Initial Pass/Fail: Fail	Overall Compliance: No
Severity Score: 13.75			
Codes/Mitigation Info/Possible Solution		Field Measurements/Component Compliance

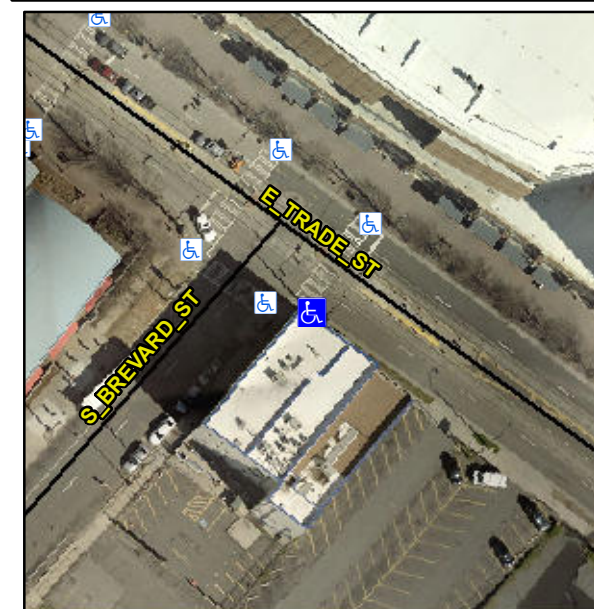
Not Found, R304.2.2, R304.5.3

Compliance	Description	Data	Compliance	Description	Data
N/A	Ramp Length (in)	45.5	No	Ramp Slope (%)	11.4
Yes	Ramp Width (in)	48.0	No	Ramp XSlope (%)	3.4
N/A	Flare Type LT	N/A	N/A	Flare Type RT	N/A
N/A	Flare Slope LT (%)	N/A	N/A	Flare Slope RT (%)	N/A
N/A	Flare Traversable LT?	N/A	N/A	Flare Traversable RT?	N/A
N/A	Landing Length (in)	N/A	N/A	DWS Provided?	N/A
N/A	Landing Width (in)	N/A	N/A	DWS Contrast?	N/A
N/A	Landing Slope (%)	N/A	N/A	DWS Length (in)	N/A
N/A	Landing X Slope (%)	N/A	N/A	DWS Full Width?	N/A
N/A	Landing Curb? (Y/N)	N/A	N/A	DWS Offset (in)	N/A
N/A	Shared Landing?	N/A			
N/A	Gutter Ponding?	N/A	N/A	Gutter Slope (%)	N/A
N/A	Gutter Lip Ht (in)	N/A	N/A	Gutter X Slope (%)	N/A
N/A	Painted X Walk1?	Yes	N/A	Painted X Walk2?	N/A
	X Walk 1 Direction	To NE		X Walk 2 Direction	N/A
N/A	X Walk 1 Width (in)	112.0	N/A	X Walk 2 Width (in)	N/A
	X Walk 1 Slope (%)	6.8		X Walk 2 Slope (%)	N/A
	X Walk 1 X Slope (%)	0.9		X Walk 2 X Slope (%)	N/A

N/A	Ramp inside XWalk1?	Yes	N/A	Ramp inside XWalk2?	N/A
	Road Slope (%)	N/A	N/A	Clear Space?	N/A
	Road X Slope (%)	N/A	N/A	Clear Space to XWalk (in)	N/A
N/A	Any Obstructions?	N/A	N/A	Storm Grate/Utility Hazard?	N/A
	Obstruction Type			Storm Grate/Utility Type	
		N/A			N/A
		Yes		Surface Condition? (G/P)	Good

Possible Solutions:

Remove & Replace Entire Ramp.

Total Cost: \$ 1850.00
