# Access Compliance Report

## Public Rights-of-Way

### (Curb Ramps)

Intersection ID: 4775	Main Street: OLD_STATESVILLE_RD	Cross Street: HENDERSON_CR	Location:	W
ADA ID: C48D8831FBCF	Ramp Type: Perp	Initial Pass/Fail: Fail	Overall Compliance: No	Severity Score: 42.5
Codes/Mitigation Info/Possible Solution		Field Measurements/Component Compliance

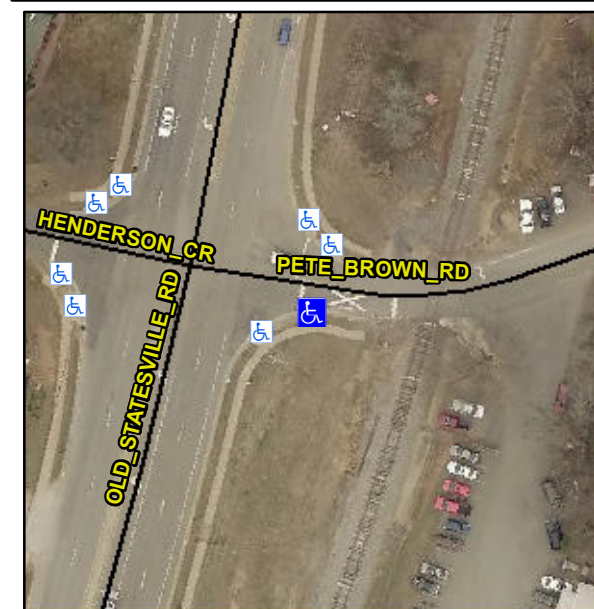
**Not Found, R304.5.1, R304.2.2**

Compliance	Description	Data	Compliance	Description	Data
N/A	Ramp Length (in)	60.0	No	Ramp Slope (%)	14.5
No	Ramp Width (in)	35.5	Yes	Ramp XSlope (%)	1.2
N/A	Flare Type LT	N/A	N/A	Flare Type RT	N/A
N/A	Flare Slope LT (%)	N/A	N/A	Flare Slope RT (%)	N/A
N/A	Flare Traversable LT?	N/A	N/A	Flare Traversable RT?	N/A
N/A	Landing Length (in)	N/A	N/A	DWS Provided?	N/A
N/A	Landing Width (in)	N/A	N/A	DWS Contrast?	N/A
N/A	Landing Slope (%)	N/A	N/A	DWS Length (in)	N/A
N/A	Landing X Slope (%)	N/A	N/A	DWS Full Width?	N/A
N/A	Landing Curb? (Y/N)	N/A	N/A	DWS Offset (in)	N/A
N/A	Shared Landing?	N/A			
N/A	Gutter Ponding?	N/A	N/A	Gutter Slope (%)	N/A
N/A	Gutter Lip Ht (in)	N/A	N/A	Gutter X Slope (%)	N/A
N/A	Painted X Walk1?	No	N/A	Painted X Walk2?	N/A
	X Walk 1 Direction	To N		X Walk 2 Direction	N/A
N/A	X Walk 1 Width (in)	N/A	N/A	X Walk 2 Width (in)	N/A
	X Walk 1 Slope (%)	0.4		X Walk 2 Slope (%)	N/A
	X Walk 1 X Slope (%)	3.1		X Walk 2 X Slope (%)	N/A

N/A	Ramp inside XWalk1?	N/A	N/A	Ramp inside XWalk2?	N/A
	Road Slope (%)	N/A	N/A	Clear Space?	N/A
	Road X Slope (%)	N/A	N/A	Clear Space to XWalk (in)	N/A
N/A	Any Obstructions?	N/A	N/A	Storm Grate/Utility Hazard?	N/A
	Obstruction Type			Storm Grate/Utility Type	
		N/A			N/A
			Yes	Surface Condition? (G/P)	Good

Possible Solutions:

**Remove & Replace Entire Ramp.**
