Access Compliance Report

Public Rights-of-Way (Curb Ramps)

Intersection ID: N/A	Main Street: S_COLLEGE_ST	Cross Street: E_HILL_ST	Location: W
ADA ID: C4961A02A9CC	Ramp Type: Para	Initial Pass/Fail: Fail	Overall Compliance: No
			Severity Score: 13.75

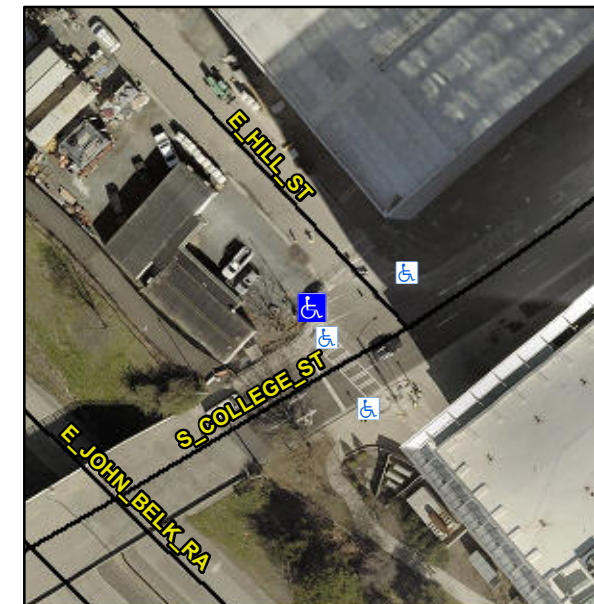
R304.3.2, R304.5.3

Compliance	Description	Data	Compliance	Description	Data
N/A	Ramp Length LT (in)	46.0	N/A	Ramp Length RT (in)	N/A
Yes	Ramp Width LT (in)	60.0	N/A	Ramp Width RT (in)	N/A
No	Ramp Slope LT (%)	10.2	N/A	Ramp Slope RT (%)	N/A
No	Ramp XSlope LT (%)	3.1	N/A	Ramp XSlope RT (%)	N/A
N/A	Landing Length (in)	N/A	N/A	DWS Provided?	N/A
N/A	Landing Width (in)	N/A	N/A	DWS Contrast?	N/A
N/A	Landing Slope (%)	N/A	N/A	DWS Length (in)	N/A
N/A	Landing X Slope (%)	N/A	N/A	DWS Full Width?	N/A
N/A	Landing Curb? (Y/N)	N/A	N/A	DWS Offset (in)	N/A
N/A	Shared Landing?	N/A			
N/A	Gutter Ponding?	N/A	N/A	Gutter Slope (%)	N/A
N/A	Gutter Lip Ht (in)	N/A	N/A	Gutter X Slope (%)	N/A
N/A	Painted X Walk1?	Yes	N/A	Painted X Walk2?	N/A
	X Walk 1 Direction	To E		X Walk 2 Direction	N/A
N/A	X Walk 1 Width (in)	104.0	N/A	X Walk 2 Width (in)	N/A
	X Walk 1 Slope (%)	1.1		X Walk 2 Slope (%)	N/A
	X Walk 1 X Slope (%)	3.0		X Walk 2 X Slope (%)	N/A
N/A	Ramp inside XWalk1?	Yes	N/A	Ramp inside XWalk2?	N/A

Road Slope (%)	N/A	N/A	Clear Space?	N/A
	Road X Slope (%)	N/A	N/A	Clear Space to XWalk (in)	N/A
N/A	Any Obstructions?	N/A	N/A	Storm Grate/Utility Hazard?	N/A
	Obstruction Type			Storm Grate/Utility Type	
		N/A			N/A
			Yes	Surface Condition? (G/P)	Good
			N/A	Curb Slope (%)	3.1

Remove & Replace Entire Ramp.
