Access Compliance Report

Public Rights-of-Way

(Curb Ramps)

Intersection ID: 47848	Main Street: ADOBE_RD	Cross Street: SERAPE_RD	Location: SE
ADA ID: C4A386844345	Ramp Type: PerpDiag	Initial Pass/Fail: Fail	Overall Compliance: No
Codes/Mitigation Info/Possible Solution		Field Measurements/Component Compliance

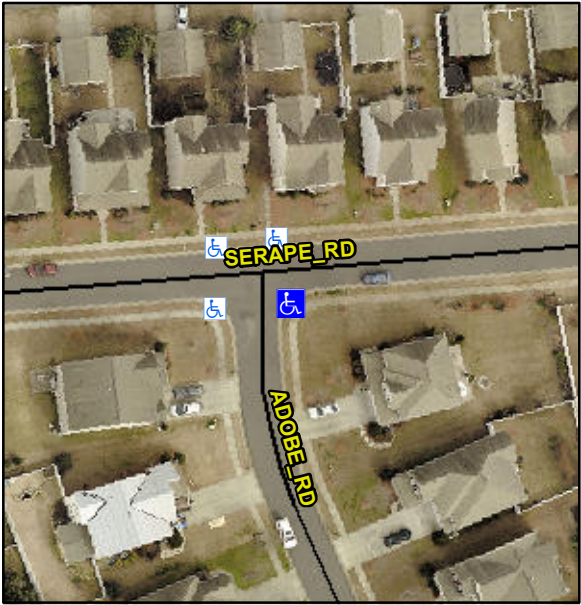
Possible Solutions:	Compliance	Description	Data	Compliance	Description	Data
	Remove & Replace Curb Ramp With Two New Directional Ramps or Equivalent.	N/A	Ramp Length (in)	48.0	No	Ramp Slope (%)	10.1
		Yes	Ramp Width (in)	48.0	Yes	Ramp XSlope (%)	1.2
		N/A	Flare Type LT	N/A	N/A	Flare Type RT	N/A
		N/A	Flare Slope LT (%)	N/A	N/A	Flare Slope RT (%)	N/A
		N/A	Flare Traversable LT?	N/A	N/A	Flare Traversable RT?	N/A
		N/A	Landing Length (in)	N/A	N/A	DWS Provided?	N/A
		N/A	Landing Width (in)	N/A	N/A	DWS Contrast?	N/A
		N/A	Landing Slope (%)	N/A	N/A	DWS Length (in)	N/A
		N/A	Landing X Slope (%)	N/A	N/A	DWS Full Width?	N/A
<p>Surveyor Notes:</p> <p>N/A</p> <p>PROW/ADA:</p> <p>R304.2.2</p>		N/A	Landing Curb? (Y/N)	N/A	N/A	DWS Offset (in)	N/A
		N/A	Shared Landing?	N/A			
		N/A	Gutter Ponding?	N/A	N/A	Gutter Slope (%)	N/A
		N/A	Gutter Lip Ht (in)	N/A	N/A	Gutter X Slope (%)	N/A
		N/A	Painted X Walk1?	No	N/A	Painted X Walk2?	No

X Walk 1 Direction	To N		X Walk 2 Direction	To W
		N/A	X Walk 1 Width (in)	N/A	N/A	X Walk 2 Width (in)	N/A
			X Walk 1 Slope (%)	5.0		X Walk 2 Slope (%)	2.2
			X Walk 1 X Slope (%)	1.4		X Walk 2 X Slope (%)	3.8
		N/A	Ramp inside XWalk1?	N/A	N/A	Ramp inside XWalk2?	N/A
<p>Street 1 Name</p> <p>Stop Condition-Street 2</p> <p>Street 2 Name</p> <p>Stop Condition-Street 1</p>			Road Slope (%)	1.2	N/A	Clear Space?	N/A
			Road X Slope (%)	4.5	N/A	Clear Space to XWalk (in)	N/A
		N/A	Any Obstructions?	N/A	N/A	Storm Grate/Utility Hazard?	N/A
			Obstruction Type			Storm Grate/Utility Type	
					N/A		N/A
					Yes	Surface Condition? (G/P)	Good
Total Cost:		\$	3200.00
