Access Compliance Report

Public Rights-of-Way

(Curb Ramps)

Intersection ID: 9622	Main Street: FAIRFIELD_ST	Cross Street: WASHINGTON_AV	Location: NE
ADA ID: C4B2D92E2799	Ramp Type: Perp	Initial Pass/Fail: Pass	Overall Compliance: No
		Severity Score: 10

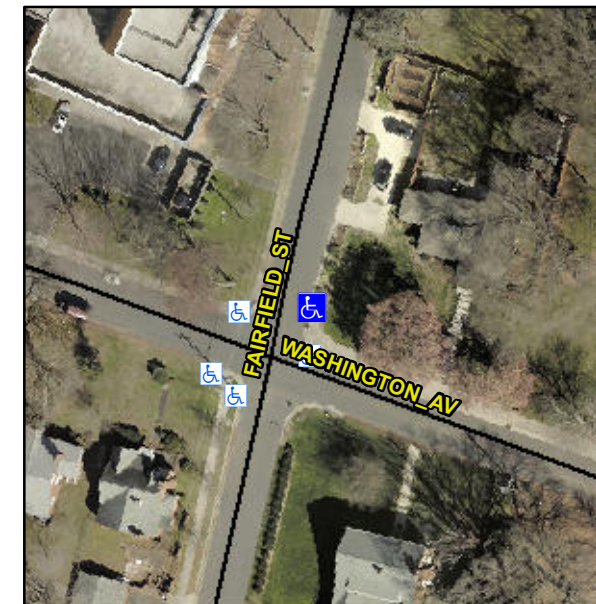
Not Found, R304.2.1, R304.2.2-Perp, R304.3.2-Para, R304.5.3, R305.2

Compliance	Description	Data	Compliance	Description	Data
N/A	Ramp Length (in)	75.5	Yes	Ramp Slope (%)	6.2
Yes	Ramp Width (in)	48.0	Yes	Ramp XSlope (%)	0.6
N/A	Flare Type LT	Sloped	N/A	Flare Type RT	N/A
N/A	Flare Slope LT (%)	6.6	Yes	Flare Slope RT (%)	5.3
N/A	Flare Traversable LT?	No	N/A	Flare Traversable RT?	Yes
No	Landing Length (in)	N/A	Yes	DWS Provided?	Yes
No	Landing Width (in)	N/A	Yes	DWS Contrast?	Yes
No	Landing Slope (%)	N/A	Yes	DWS Length (in)	24.0
No	Landing X Slope (%)	N/A	Yes	DWS Full Width?	Yes
N/A	Landing Curb? (Y/N)	No	No	DWS Offset (in)	3.5
N/A	Shared Landing?	No			
Yes	Gutter Ponding?	No	Yes	Gutter Slope (%)	4.0
Yes	Gutter Lip Ht (in)	0.0	Yes	Gutter X Slope (%)	1.1
N/A	Painted X Walk1?	No	N/A	Painted X Walk2?	N/A
	X Walk 1 Direction	To W		X Walk 2 Direction	N/A
N/A	X Walk 1 Width (in)	N/A	N/A	X Walk 2 Width (in)	N/A
	X Walk 1 Slope (%)	4.6		X Walk 2 Slope (%)	N/A
	X Walk 1 X Slope (%)	0.3		X Walk 2 X Slope (%)	N/A

N/A	Ramp inside XWalk1?	N/A	N/A	Ramp inside XWalk2?	N/A
	Road Slope (%)	N/A	N/A	Clear Space?	Yes
	Road X Slope (%)	N/A	N/A	Clear Space to XWalk (in)	N/A
Yes	Any Obstructions?	No	Yes	Storm Grate/Utility Hazard?	No
	Obstruction Type			Storm Grate/Utility Type	
		N/A			N/A
			Yes	Surface Condition? (G/P)	Good

Remove & Replace Entire Ramp.
