Access Compliance Report

Public Rights-of-Way

(Curb Ramps)

Intersection ID: 31523	Main Street: BACK_ACRE_DR	Cross Street: CALDWELL_RIDGE_PY	Location: S
ADA ID: C4C54B36066F	Ramp Type: BlendTrans1	Initial Pass/Fail: Pass	Overall Compliance: No
		Severity Score: 17.5

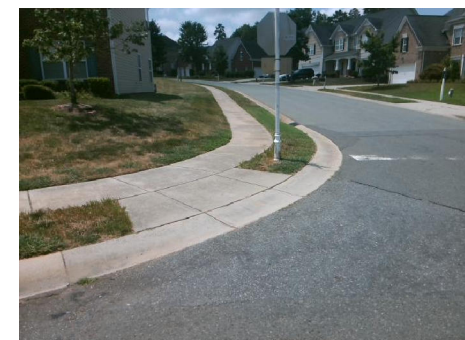
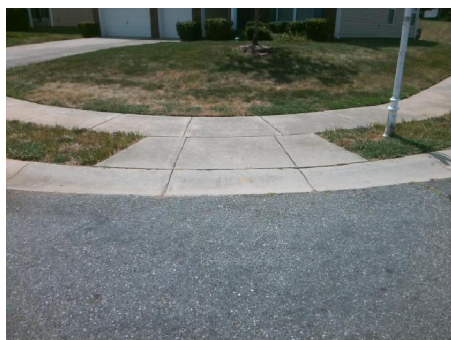
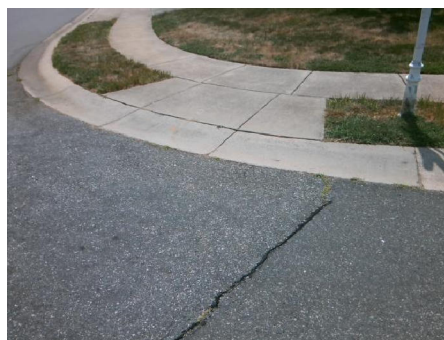
Not Found, R304.2.1, R304.2.2-Perp, R304.3.2-Para, R305, R302.7.2

Compliance	Description	Data	Compliance	Description	Data
N/A	Ramp Length (in)	46.0	Yes	BlendTrans Slope (%)	4.6
Yes	Ramp Width (in)	50.0	Yes	BlendTrans XSlope (%)	0.8
N/A	Flare Type LT	Sloped	N/A	Flare Type RT	Sloped
N/A	Flare Slope LT (%)	1.1	N/A	Flare Slope RT (%)	3.6
N/A	Flare Traversable LT?	No	N/A	Flare Traversable RT?	No
Yes	Landing Length (in)	48.0	No	DWS Provided?	No
No	Landing Width (in)	47.0	N/A	DWS Contrast?	No
No	Landing Slope (%)	2.3	N/A	DWS Length (in)	N/A
Yes	Landing X Slope (%)	1.9	N/A	DWS Full Width?	No
N/A	Landing Curb? (Y/N)	No	N/A	DWS Offset (in)	N/A
N/A	Shared Landing?	No			
Yes	Gutter Ponding?	No	Yes	Gutter Slope (%)	3.3
No	Gutter Lip Ht (in)	0.3	Yes	Gutter X Slope (%)	1.6
N/A	Painted X Walk1?	No	N/A	Painted X Walk2?	No
	X Walk 1 Direction	To NE		X Walk 2 Direction	To NW
	X Walk 1 Width (in)	N/A		X Walk 2 Width (in)	N/A
	X Walk 1 Slope (%)	3.3		X Walk 2 Slope (%)	2.9
	X Walk 1 X Slope (%)	0.5		X Walk 2 X Slope (%)	4.2

N/A	Ramp inside XWalk1?	N/A	N/A	Ramp inside XWalk2?	N/A
	Road Slope (%)	0.4		Clear Space?	Yes
	Road X Slope (%)	3.5	N/A	Clear Space to XWalk (in)	N/A
Yes	Any Obstructions?	No	Yes	Storm Grate/Utility Hazard?	No
	Obstruction Type			Storm Grate/Utility Type	
		N/A			N/A
			Yes	Surface Condition? (G/P)	Good
			No	Curb Slope (%)	15.9

Remove & Replace Curb Ramp With Two New Directional Ramps or Equivalent.

Total Cost: \$ 3200.00
