# Access Compliance Report

## Public Rights-of-Way (Curb Ramps)

| Intersection ID: 54301 | Main Street: GOLF_LINKS_DR | Cross Street: PROVIDENCE_FARM_LN | Location: NW |
| ADA ID: C4C8576928D1 | Ramp Type: Directional1 | Initial Pass/Fail: Pass | Overall Compliance: No |

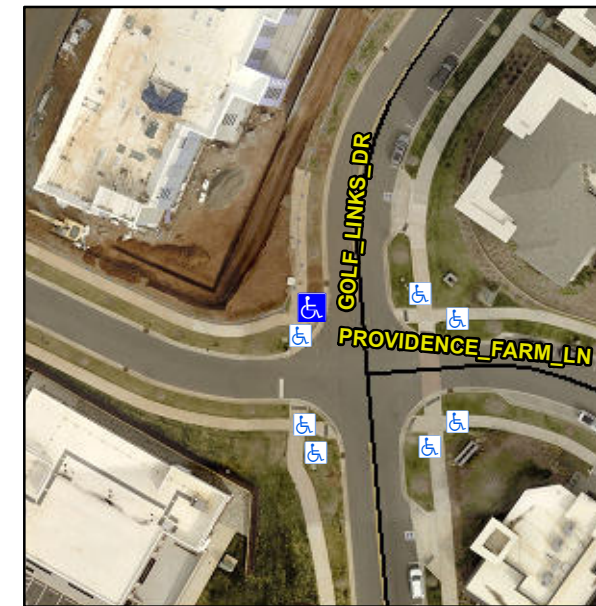
**R304.5.3, R304.5.2, R302.7.2**

| Compliance | Description | Data | Compliance | Description | Data |
|---|---|---|---|---|---|
| No | Ramp XSlope (%) | 3.5 | | | |
| No | Gutter Lip Ht (in) | 2.0 | Yes | Gutter X Slope (%) | 2.0 |

**Remove & Replace Entire Ramp.  
Grind Gutter Lip.**
