Access Compliance Report

Public Rights-of-Way

(Curb Ramps)

Intersection ID: 10038956	Main Street: STONEMEDE_LN	Cross Street: N/A	Location: E
ADA ID: C4CA3235F6AE	Ramp Type: Perp	Initial Pass/Fail: Pass	Overall Compliance: No
			Severity Score: 7.75
Codes/Mitigation Info/Possible Solution		Field Measurements/Component Compliance

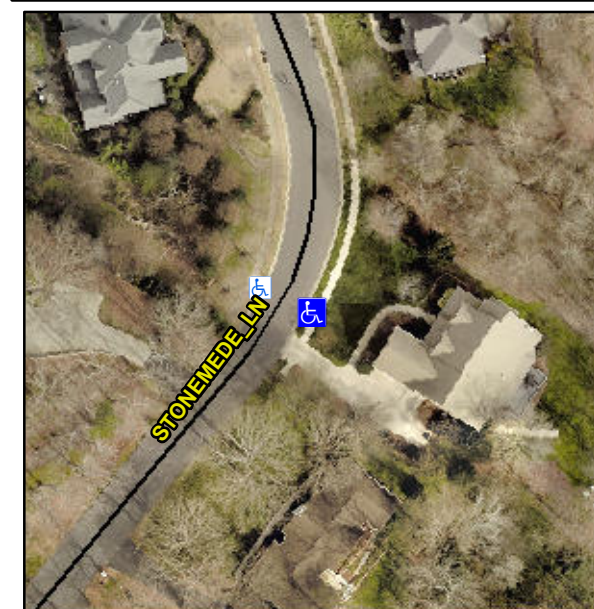
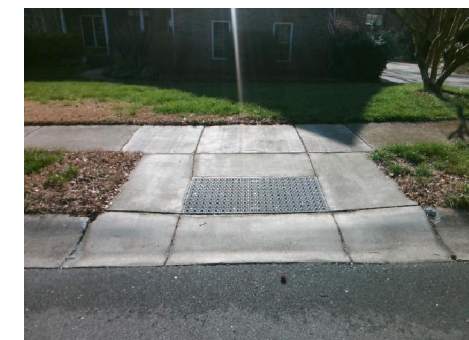
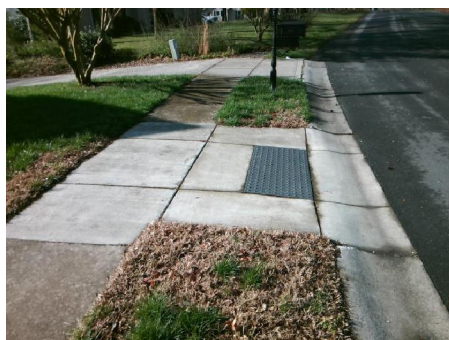
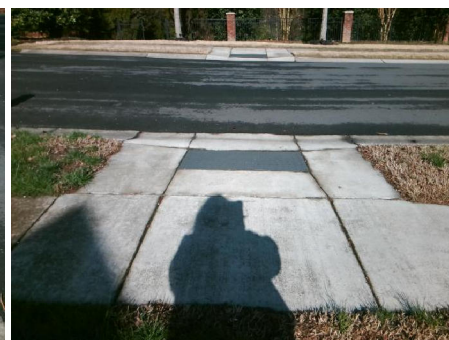
**Not Found, R304.2.3, R304.5.4,
R304.5.3**

Compliance	Description	Data	Compliance	Description	Data
N/A	Ramp Length (in)	47.5	Yes	Ramp Slope (%)	7.3
Yes	Ramp Width (in)	48.0	Yes	Ramp XSlope (%)	4.1
N/A	Flare Type LT	Sloped	N/A	Flare Type RT	N/A
N/A	Flare Slope LT (%)	4.8	No	Flare Slope RT (%)	11.8
N/A	Flare Traversable LT?	Yes	N/A	Flare Traversable RT?	Yes
Yes	Landing Length (in)	48.0	Yes	DWS Provided?	Yes
Yes	Landing Width (in)	48.0	Yes	DWS Contrast?	Yes
Yes	Landing Slope (%)	1.1	Yes	DWS Length (in)	24.0
Yes	Landing X Slope (%)	4.4	Yes	DWS Full Width?	Yes
N/A	Landing Curb? (Y/N)	No	Yes	DWS Offset (in)	0.0
N/A	Shared Landing?	No			
Yes	Gutter Ponding?	No	No	Gutter Slope (%)	6.4
Yes	Gutter Lip Ht (in)	0.0	No	Gutter X Slope (%)	5.4
N/A	Painted X Walk1?	No	N/A	Painted X Walk2?	N/A
	X Walk 1 Direction	To NW		X Walk 2 Direction	N/A
N/A	X Walk 1 Width (in)	N/A	N/A	X Walk 2 Width (in)	N/A
	X Walk 1 Slope (%)	3.5		X Walk 2 Slope (%)	N/A
	X Walk 1 X Slope (%)	4.5		X Walk 2 X Slope (%)	N/A

N/A	Ramp inside XWalk1?	N/A	N/A	Ramp inside XWalk2?	N/A
	Road Slope (%)	N/A	N/A	Clear Space?	Yes
	Road X Slope (%)	N/A	N/A	Clear Space to XWalk (in)	N/A
Yes	Any Obstructions?	No	Yes	Storm Grate/Utility Hazard?	No
	Obstruction Type			Storm Grate/Utility Type	
		N/A			N/A
			Yes	Surface Condition? (G/P)	Good

Possible Solutions:

**Remove & Replace Entire Ramp.
Remove & Replace Gutter.**
