# Access Compliance Report

## Public Rights-of-Way

### (Curb Ramps)

Intersection ID: N/A	Main Street: E_W_T_HARRIS_BV	Cross Street: N/A	Location: SE
ADA ID: C4CAA79757B2	Ramp Type: PerpDiag	Initial Pass/Fail: Fail	Overall Compliance: No
		Severity Score: 12.5

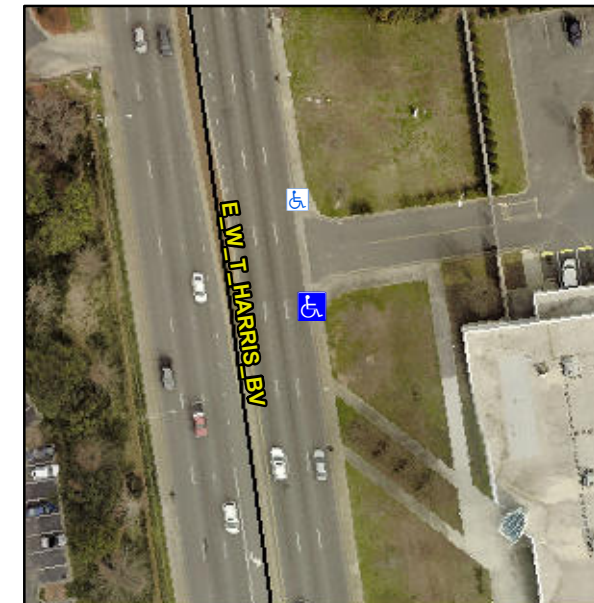
Compliance	Description	Data	Compliance	Description	Data
N/A	Ramp Length (in)	71.0	No	Ramp Slope (%)	9.4
Yes	Ramp Width (in)	54.0	Yes	Ramp XSlope (%)	1.8
N/A	Flare Type LT	N/A	N/A	Flare Type RT	N/A
N/A	Flare Slope LT (%)	N/A	N/A	Flare Slope RT (%)	N/A
N/A	Flare Traversable LT?	N/A	N/A	Flare Traversable RT?	N/A
N/A	Landing Length (in)	N/A	N/A	DWS Provided?	N/A
N/A	Landing Width (in)	N/A	N/A	DWS Contrast?	N/A
N/A	Landing Slope (%)	N/A	N/A	DWS Length (in)	N/A
N/A	Landing X Slope (%)	N/A	N/A	DWS Full Width?	N/A
N/A	Landing Curb? (Y/N)	N/A	N/A	DWS Offset (in)	N/A
N/A	Shared Landing?	N/A			
N/A	Gutter Ponding?	N/A	N/A	Gutter Slope (%)	N/A
N/A	Gutter Lip Ht (in)	N/A	N/A	Gutter X Slope (%)	N/A
N/A	Painted X Walk1?	No	N/A	Painted X Walk2?	No
	X Walk 1 Direction	To N		X Walk 2 Direction	To W
N/A	X Walk 1 Width (in)	N/A	N/A	X Walk 2 Width (in)	N/A
	X Walk 1 Slope (%)	3.0		X Walk 2 Slope (%)	1.2
	X Walk 1 X Slope (%)	1.9		X Walk 2 X Slope (%)	0.9

N/A	Ramp inside XWalk1?	N/A	N/A	Ramp inside XWalk2?	N/A
	Road Slope (%)	0.4	N/A	Clear Space?	N/A
	Road X Slope (%)	1.3	N/A	Clear Space to XWalk (in)	N/A
N/A	Any Obstructions?	N/A	N/A	Storm Grate/Utility Hazard?	N/A
	Obstruction Type			Storm Grate/Utility Type	
		N/A			N/A
		Yes		Surface Condition? (G/P)	Good

**Remove & Replace Curb Ramp With Two New Directional Ramps or Equivalent.**

**R304.2.2**
