Access Compliance Report

Public Rights-of-Way

(Curb Ramps)

Intersection ID: 4086	Main Street: CLAYBROOKE_DR	Cross Street: SANRIDGE_WIND_LN	Location: NE
ADA ID: C4CD63DAA924	Ramp Type: Perp	Initial Pass/Fail: Fail	Overall Compliance: No
Severity Score: 10			
Codes/Mitigation Info/Possible Solution		Field Measurements/Component Compliance

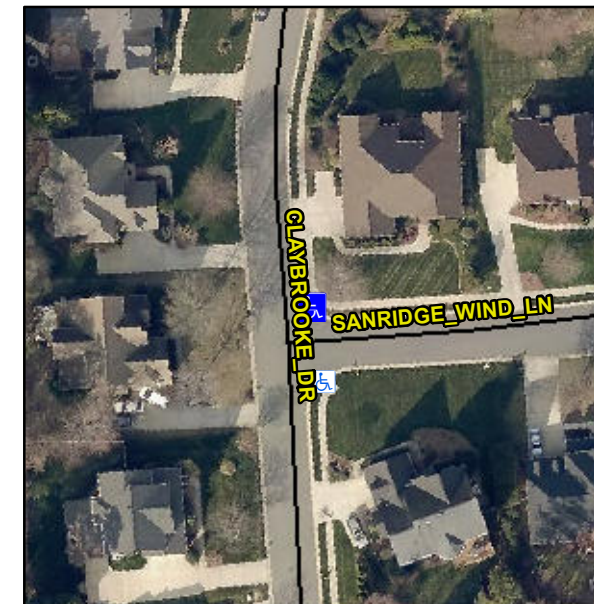
Not Found, R304.5.1, R304.5.3

Compliance	Description	Data	Compliance	Description	Data
N/A	Ramp Length (in)	66.0	Yes	Ramp Slope (%)	7.1
No	Ramp Width (in)	45.5	No	Ramp XSlope (%)	2.7
N/A	Flare Type LT	N/A	N/A	Flare Type RT	N/A
N/A	Flare Slope LT (%)	N/A	N/A	Flare Slope RT (%)	N/A
N/A	Flare Traversable LT?	N/A	N/A	Flare Traversable RT?	N/A
N/A	Landing Length (in)	N/A	N/A	DWS Provided?	N/A
N/A	Landing Width (in)	N/A	N/A	DWS Contrast?	N/A
N/A	Landing Slope (%)	N/A	N/A	DWS Length (in)	N/A
N/A	Landing X Slope (%)	N/A	N/A	DWS Full Width?	N/A
N/A	Landing Curb? (Y/N)	N/A	N/A	DWS Offset (in)	N/A
N/A	Shared Landing?	N/A			
N/A	Gutter Ponding?	N/A	N/A	Gutter Slope (%)	N/A
N/A	Gutter Lip Ht (in)	N/A	N/A	Gutter X Slope (%)	N/A
N/A	Painted X Walk1?	No	N/A	Painted X Walk2?	N/A
	X Walk 1 Direction	To S		X Walk 2 Direction	N/A
N/A	X Walk 1 Width (in)	N/A	N/A	X Walk 2 Width (in)	N/A
	X Walk 1 Slope (%)	7.6		X Walk 2 Slope (%)	N/A
	X Walk 1 X Slope (%)	2.7		X Walk 2 X Slope (%)	N/A

Remove & Replace Entire Ramp.
