# Access Compliance Report

## Public Rights-of-Way

### (Curb Ramps)

Intersection ID: 9382	Main Street: RUPERT_LN	Cross Street: COVECREEK_DR	Location: SW
ADA ID: C4F4D8EEDDCB	Ramp Type: Perp	Initial Pass/Fail: Fail	Overall Compliance: No
Codes/Mitigation Info/Possible Solution		Field Measurements/Component Compliance	
Severity Score: 18.75

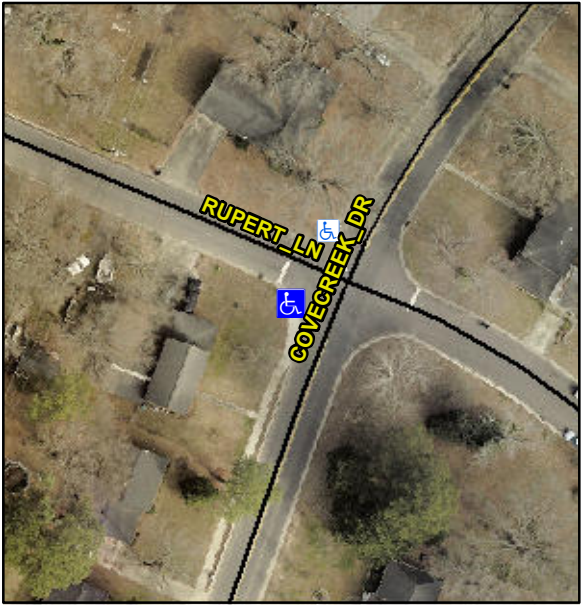
Possible Solutions:						
	Remove & Replace Entire Ramp.						
	Surveyor Notes:						
	N/A						
	PROW/ADA:						
	Not Found, R304.5.1, R304.5.3						
		Compliance	Description	Data	Compliance	Description	Data
		N/A	Ramp Length (in)	48.0	Yes	Ramp Slope (%)	5.8
		No	Ramp Width (in)	35.0	No	Ramp XSlope (%)	2.4
		N/A	Flare Type LT	N/A	N/A	Flare Type RT	N/A
<p>Street 1 Name</p> <p>Stop Condition-Street 2</p> <p>Street 2 Name</p> <p>Stop Condition-Street 1</p>		N/A	Flare Slope LT (%)	N/A	N/A	Flare Slope RT (%)	N/A
		N/A	Flare Traversable LT?	N/A	N/A	Flare Traversable RT?	N/A
		N/A	Landing Length (in)	N/A	N/A	DWS Provided?	N/A
		N/A	Landing Width (in)	N/A	N/A	DWS Contrast?	N/A
		N/A	Landing Slope (%)	N/A	N/A	DWS Length (in)	N/A
		N/A	Landing X Slope (%)	N/A	N/A	DWS Full Width?	N/A
		N/A	Landing Curb? (Y/N)	N/A	N/A	DWS Offset (in)	N/A
		N/A	Shared Landing?	N/A			
		N/A	Gutter Ponding?	N/A	N/A	Gutter Slope (%)	N/A

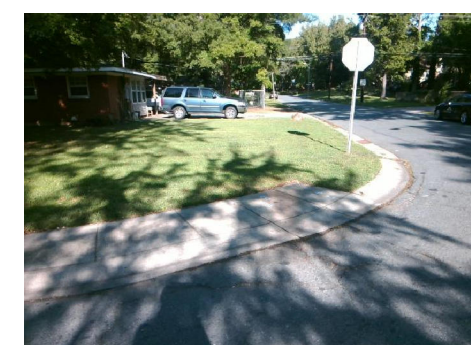
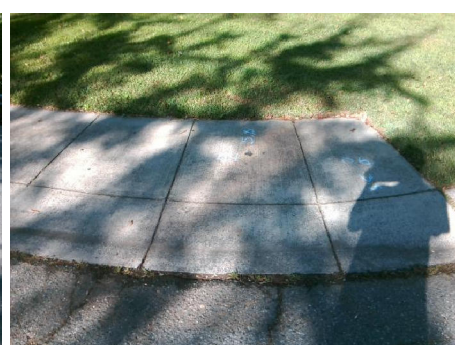
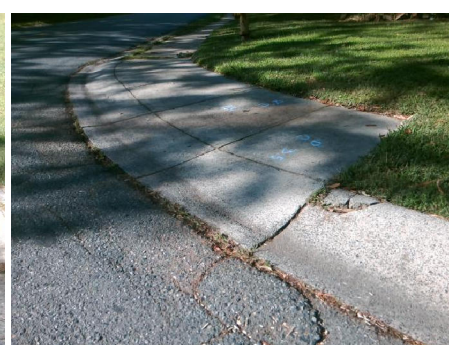
N/A	Gutter Lip Ht (in)	1.0	N/A	Gutter X Slope (%)	N/A
<p>Total Cost:</p> <p>\$ 1850.00</p>		N/A	Painted X Walk1?	No	N/A	Painted X Walk2?	N/A
			X Walk 1 Direction	To NE		X Walk 2 Direction	N/A
		N/A	X Walk 1 Width (in)	N/A	N/A	X Walk 2 Width (in)	N/A
			X Walk 1 Slope (%)	3.5		X Walk 2 Slope (%)	N/A
			X Walk 1 X Slope (%)	0.6		X Walk 2 X Slope (%)	N/A
		N/A	Ramp inside XWalk1?	N/A	N/A	Ramp inside XWalk2?	N/A
			Road Slope (%)	N/A	N/A	Clear Space?	N/A
			Road X Slope (%)	N/A	N/A	Clear Space to XWalk (in)	N/A
		N/A	Any Obstructions?	N/A	N/A	Storm Grate/Utility Hazard?	N/A
			Obstruction Type			Storm Grate/Utility Type	
<p>Yes</p>		N/A			N/A		N/A
		Yes	Surface Condition? (G/P)		Good
