Access Compliance Report

Public Rights-of-Way

(Curb Ramps)

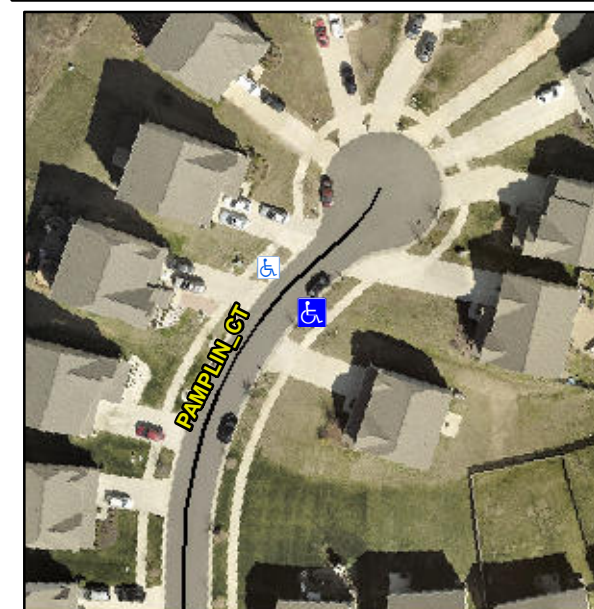
Intersection ID: N/A	Main Street: PAMPLIN_CT	Cross Street: N/A	Location: SE
ADA ID: C4F83ADFCB64	Ramp Type: Perp	Initial Pass/Fail: Fail	Overall Compliance: No
Codes/Mitigation Info/Possible Solution		Field Measurements/Component Compliance	
Severity Score: 33.75

Not Found, R304.5.1, R304.2.2

Compliance	Description	Data	Compliance	Description	Data
N/A	Ramp Length (in)	93.0	No	Ramp Slope (%)	13.6
No	Ramp Width (in)	46.5	Yes	Ramp XSlope (%)	1.1
N/A	Flare Type LT	N/A	N/A	Flare Type RT	N/A
N/A	Flare Slope LT (%)	N/A	N/A	Flare Slope RT (%)	N/A
N/A	Flare Traversable LT?	N/A	N/A	Flare Traversable RT?	N/A
N/A	Landing Length (in)	N/A	N/A	DWS Provided?	N/A
N/A	Landing Width (in)	N/A	N/A	DWS Contrast?	N/A
N/A	Landing Slope (%)	N/A	N/A	DWS Length (in)	N/A
N/A	Landing X Slope (%)	N/A	N/A	DWS Full Width?	N/A
N/A	Landing Curb? (Y/N)	N/A	N/A	DWS Offset (in)	N/A
N/A	Shared Landing?	N/A			
N/A	Gutter Ponding?	N/A	N/A	Gutter Slope (%)	N/A
N/A	Gutter Lip Ht (in)	N/A	N/A	Gutter X Slope (%)	N/A
N/A	Painted X Walk1?	No	N/A	Painted X Walk2?	N/A
	X Walk 1 Direction	To NW		X Walk 2 Direction	N/A
N/A	X Walk 1 Width (in)	N/A	N/A	X Walk 2 Width (in)	N/A
	X Walk 1 Slope (%)	2.8		X Walk 2 Slope (%)	N/A
	X Walk 1 X Slope (%)	1.4		X Walk 2 X Slope (%)	N/A

N/A	Ramp inside XWalk1?	N/A	N/A	Ramp inside XWalk2?	N/A
	Road Slope (%)	N/A	N/A	Clear Space?	N/A
	Road X Slope (%)	N/A	N/A	Clear Space to XWalk (in)	N/A
N/A	Any Obstructions?	N/A	N/A	Storm Grate/Utility Hazard?	N/A
	Obstruction Type			Storm Grate/Utility Type	
		N/A			N/A
			Yes	Surface Condition? (G/P)	Good

Possible Solutions:

Remove & Replace Entire Ramp.
