Access Compliance Report Public Rights-of-Way (Curb Ramps)

Intersection ID: 29384 Main Street: KIERNAN_DR Cross Street: PLEASANT_DALE_DR Location: NW
ADA ID: C4FF7BAF1085 Ramp Type: Perp Initial Pass/Fail: Fail Overall Compliance: No Severity Score: 13.75

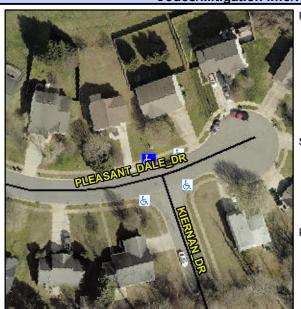
Field Measurements/Component Compliance								
Compliance Description		Data	Compl	iance Description	Data			
N/A	Ramp Length (in)	47.0	No	Ramp Slope (%)	8.4			
Yes	Ramp Width (in)	48.0	No	Ramp XSlope (%)	4.6			
N/A	Flare Type LT	N/A	N/A	Flare Type RT	N/A			
N/A	Flare Slope LT (%)	N/A	N/A	Flare Slope RT (%)	N/A			
N/A	Flare Traversable LT?	N/A	N/A	Flare Traversable RT?	N/A			
N/A	Landing Length (in)	N/A	N/A	DWS Provided?	N/A			
N/A	Landing Width (in)	N/A	N/A	DWS Contrast?	N/A			
N/A	Landing Slope (%)	N/A	N/A	DWS Length (in)	N/A			
N/A	Landing X Slope (%)	N/A	N/A	DWS Full Width?	N/A			
N/A	Landing Curb? (Y/N)	N/A	N/A	DWS Offset (in)	N/A			
N/A	Shared Landing?	N/A						
N/A	Gutter Ponding?	N/A	N/A	Gutter Slope (%)	N/A			
N/A	Gutter Lip Ht (in)	N/A	N/A	Gutter X Slope (%)	N/A			
N/A	Painted X Walk1?	No	N/A	Painted X Walk2?	N/A			
	X Walk 1 Direction	To SW		X Walk 2 Direction	N/A			
N/A	X Walk 1 Width (in)	N/A	N/A	X Walk 2 Width (in)	N/A

Possible Solutions:	9
3	Remove & Replace Entire Ramp.	ı
d)
		1
		1
	Surveyor Notes:	N N
S. Contraction	N/A	1
		N
		1
		N
1	PROW/ADA:	1
	Not Found, R304.2.2, R304.5.3	N
Sales .		N
No.		ŀ
		N
