Access Compliance Report Public Rights-of-Way (Curb Ramps)

Intersection ID: 18716 Main Street: COLONY_RD Cross Street: RUNNYMEDE_LN Location: NW **Overall Compliance: No** ADA ID: C501DE68964E Ramp Type: Perp Initial Pass/Fail: Fail **Severity Score:** 10

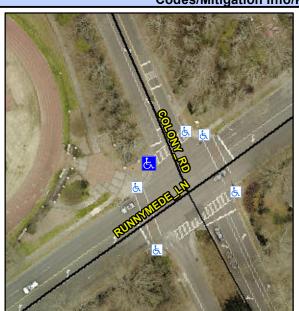
| Possible Solutions: | 9 | | |
|---|---|--|--|
| Not Found, R304.5.1 | N | | |

| Field Measurements/Component Compliance | | | | | | | | |
|---|---|---|---|---|---|---|--|--|
| No | Ramp Width (in) | 40.5 | Yes | Ramp | XSlope (%) | 2.2 | | |

| Possible Solutions: | 9 | | |
|---|---|--|--|
| Remove & Replace Entire Ramp. | | | |
