Access Compliance Report

Public Rights-of-Way

(Curb Ramps)

Intersection ID: 31891	Main Street: CENTERLINE_DR	Cross Street: MOUNTAIN_SPRINGS_DR	Location: E
ADA ID: C50AE7D00227	Ramp Type: PerpDiag	Initial Pass/Fail: Fail	Overall Compliance: No
		Severity Score: 10

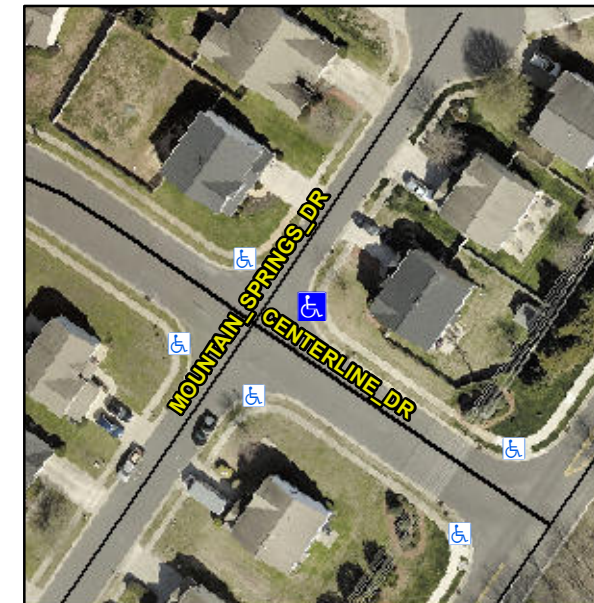
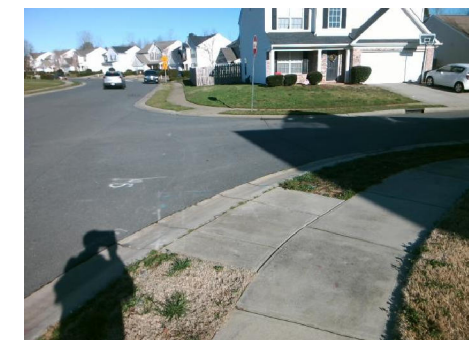
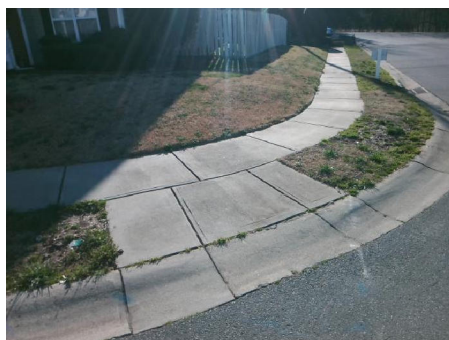
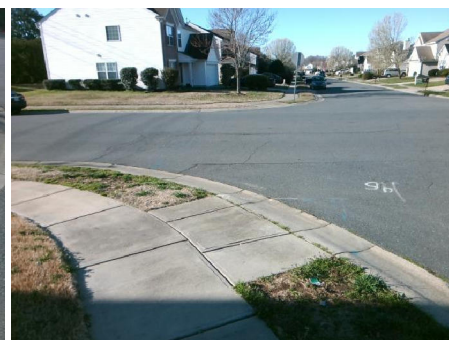
Not Found, R304.5.1, R304.5.3

Compliance	Description	Data	Compliance	Description	Data
N/A	Ramp Length (in)	46.0	Yes	Ramp Slope (%)	6.7
No	Ramp Width (in)	39.0	No	Ramp XSlope (%)	2.1
N/A	Flare Type LT	N/A	N/A	Flare Type RT	N/A
N/A	Flare Slope LT (%)	N/A	N/A	Flare Slope RT (%)	N/A
N/A	Flare Traversable LT?	N/A	N/A	Flare Traversable RT?	N/A
N/A	Landing Length (in)	N/A	N/A	DWS Provided?	N/A
N/A	Landing Width (in)	N/A	N/A	DWS Contrast?	N/A
N/A	Landing Slope (%)	N/A	N/A	DWS Length (in)	N/A
N/A	Landing X Slope (%)	N/A	N/A	DWS Full Width?	N/A
N/A	Landing Curb? (Y/N)	N/A	N/A	DWS Offset (in)	N/A
N/A	Shared Landing?	N/A			
N/A	Gutter Ponding?	N/A	N/A	Gutter Slope (%)	N/A
N/A	Gutter Lip Ht (in)	N/A	N/A	Gutter X Slope (%)	N/A
N/A	Painted X Walk1?	No	N/A	Painted X Walk2?	No
	X Walk 1 Direction	To NW		X Walk 2 Direction	To SW
N/A	X Walk 1 Width (in)	N/A	N/A	X Walk 2 Width (in)	N/A
	X Walk 1 Slope (%)	1.6		X Walk 2 Slope (%)	1.3
	X Walk 1 X Slope (%)	0.3		X Walk 2 X Slope (%)	3.2

N/A	Ramp inside XWalk1?	N/A	N/A	Ramp inside XWalk2?	N/A
	Road Slope (%)	2.4	N/A	Clear Space?	N/A
	Road X Slope (%)	1.7	N/A	Clear Space to XWalk (in)	N/A
N/A	Any Obstructions?	N/A	N/A	Storm Grate/Utility Hazard?	N/A
	Obstruction Type			Storm Grate/Utility Type	
		N/A			N/A
			Yes	Surface Condition? (G/P)	Good

Remove & Replace Curb Ramp With Two New Directional Ramps or Equivalent.

Total Cost: \$ 3200.00
