Access Compliance Report

Public Rights-of-Way

(Curb Ramps)

Intersection ID: 52365	Main Street: DUNAVANT_ST	Cross Street: MERVE_PL	Location: SE
ADA ID: C514E4AA17F5	Ramp Type: Directional1	Initial Pass/Fail: Fail	Overall Compliance: No
Severity Score: 13.75			
Codes/Mitigation Info/Possible Solution		Field Measurements/Component Compliance

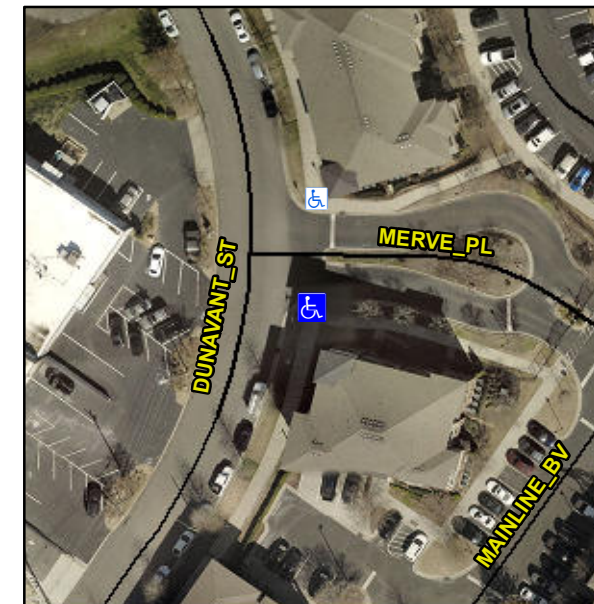
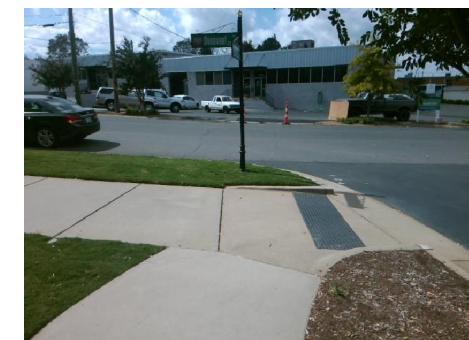
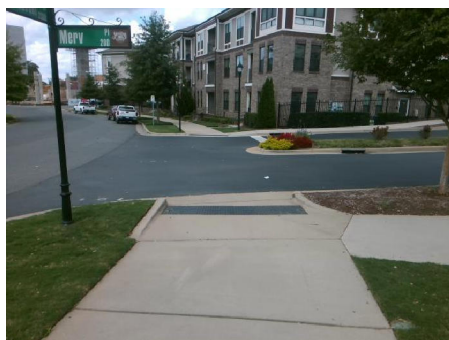
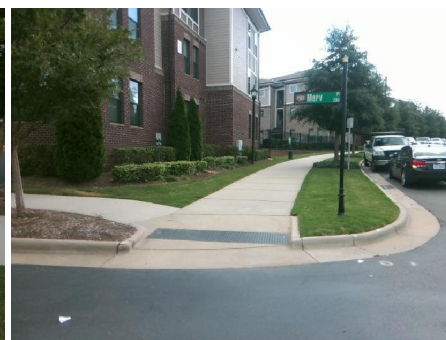
R304.2.2, R304.5.3

Compliance	Description	Data	Compliance	Description	Data
N/A	Ramp Length (in)	78.0	N/A	Grade Break?	N/A
Yes	Ramp Width (in)	96.0	N/A	Grade Break Slope (%)	0.0
No	Ramp Slope (%)	8.6	N/A	Grade Break XSlope (%)	0.0
No	Ramp XSlope (%)	2.7			
N/A	Flare Type LT	N/A	N/A	Flare Type RT	N/A
N/A	Flare Slope LT (%)	N/A	N/A	Flare Slope RT (%)	0.0
N/A	Flare Traversable LT?	N/A	N/A	Flare Traversable RT?	N/A
N/A	Landing Length (in)	0.0	N/A	DWS Provided?	N/A
N/A	Landing Width (in)	0.0	N/A	DWS Contrast?	N/A
N/A	Landing Slope (%)	0.0	N/A	DWS Length (in)	N/A
N/A	Landing X Slope (%)	0.0	N/A	DWS Full Width?	N/A
N/A	Landing Curb? (Y/N)	N/A	N/A	DWS Offset LT (in)	N/A
N/A	Shared Landing?	N/A	N/A	DWS Offset RT (in)	N/A
N/A	Gutter Ponding?	0.0	N/A	Gutter Slope (%)	N/A
N/A	Gutter Lip Ht (in)	0.0	N/A	Gutter X Slope (%)	N/A
N/A	Painted X Walk1?	No		Road Slope (%)	3.5
	X Walk 1 Direction	To NW		Road X Slope (%)	1.7
	X Walk 1 Width (in)	N/A		Clear Space?	N/A

X Walk 1 Slope (%)	3.5	N/A	Clear Space to XWalk (in)	N/A
	X Walk 1 X Slope (%)	1.7	N/A	Storm Grate/Utility Hazard?	N/A
N/A	Ramp inside XWalk1?	N/A		Storm Grate/Utility Type	
N/A	Any Obstructions?	N/A			N/A
	Obstruction Type		Yes	Surface Condition? (G/P)	Good
			N/A	Curb Slope (%)	8.3

Remove & Replace Entire Ramp.
