Access Compliance Report Public Rights-of-Way (Curb Ramps)

Intersection ID: 24849 Main Street: KING_EIDER_DR **Cross Street: WIDGEON_CT** Location: NE Ramp Type: Directional1 **Overall Compliance: No** ADA ID: C51653A25C8E Initial Pass/Fail: Fail **Severity Score:** 12.5

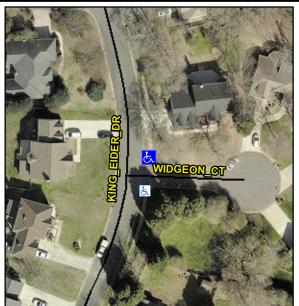
Field Measurements/Component Compliance								
Compli	ance Description	Data	Comp	liance Description	Data			
N/A	Ramp Length (in)	22.0	N/A	Grade Break?	N/A			
Yes	Ramp Width (in)	48.0	N/A	A Grade Break Slope (%)				
Yes	Ramp Slope (%)	6.6	N/A	I/A Grade Break XSlope (%)				
No	Ramp XSlope (%)	5.3						
N/A	Flare Type LT	N/A	N/A	A Flare Type RT				
N/A	Flare Slope LT (%)	N/A	N/A	Flare Slope RT (%)	0.0			
N/A	Flare Traversable LT?	N/A	N/A	Flare Traversable RT?	N/A			
N/A	Landing Length (in)	0.0	N/A	DWS Provided?	N/A			
N/A	Landing Width (in)	0.0	N/A	DWS Contrast?	N/A			
N/A	Landing Slope (%)	0.0	N/A	DWS Length (in)	N/A			
N/A	Landing X Slope (%)	0.0	N/A	DWS Full Width?	N/A			
N/A	Landing Curb? (Y/N)	N/A	N/A	DWS Offset LT (in)	N/A			
N/A	Shared Landing?	N/A	N/A	DWS Offset RT (in)	N/A			
N/A	Gutter Ponding?	0.0	N/A	Gutter Slope (%)	N/A			
N/A	Gutter Lip Ht (in)	0.0	N/A	Gutter X Slope (%)	N/A			
N/A	Painted X Walk1?	No		Road Slope (%)	3.3

X Walk 1 Direction	To S		Road X Slope (%)	3.6			
	X Walk 1 Width (in)	N/A		Clear Space?	N/A			
	X Walk 1 Slope (%)	3.3	N/A	Clear Space to XWalk (in)	N/A			
	X Walk 1 X Slope (%)	3.6	N/A	Storm Grate/Utility Hazard?	N/A			
N/A	Ramp inside XWalk1?	N/A		Storm Grate/Utility Type				
N/A	Any Obstructions?	N/A			N/A			
	Obstruction Type		Yes	Surface Condition? (G/P)	Good			
		N/A	N/A	Curb Slope (%)	34.4

Possible Solutions:						
Remove & Replace Entire Ramp.						
Surveyor Notes:						
N/A						
PROW/ADA:						
R304.5.3

R304.5.3		
Total Cost:	\$ 1600.00
