Access Compliance Report

Public Rights-of-Way (Curb Ramps)

Intersection ID: 22863	Main Street: ARBOR RIDGE DR	Cross Street: CEDAR CROSSINGS DR	Location: NW
ADA ID: C5170B134DAD	Ramp Type: Perp	Initial Pass/Fail: Fail	Overall Compliance: No
Severity Score: 12.5			
Codes/Mitigation Info/Possible Solution		Field Measurements/Component Compliance

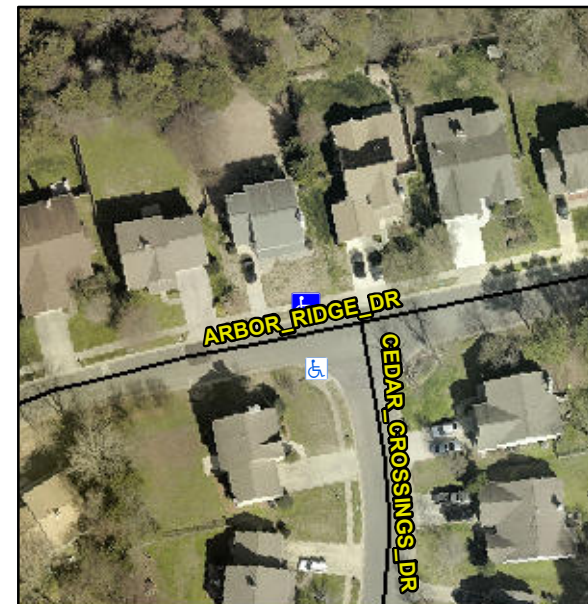
Not Found, R304.2.2

Compliance	Description	Data	Compliance	Description	Data
N/A	Ramp Length (in)	45.5	No	Ramp Slope (%)	10.2
Yes	Ramp Width (in)	48.0	Yes	Ramp XSlope (%)	0.5
N/A	Flare Type LT	N/A	N/A	Flare Type RT	N/A
N/A	Flare Slope LT (%)	N/A	N/A	Flare Slope RT (%)	N/A
N/A	Flare Traversable LT?	N/A	N/A	Flare Traversable RT?	N/A
N/A	Landing Length (in)	N/A	N/A	DWS Provided?	N/A
N/A	Landing Width (in)	N/A	N/A	DWS Contrast?	N/A
N/A	Landing Slope (%)	N/A	N/A	DWS Length (in)	N/A
N/A	Landing X Slope (%)	N/A	N/A	DWS Full Width?	N/A
N/A	Landing Curb? (Y/N)	N/A	N/A	DWS Offset (in)	N/A
N/A	Shared Landing?	N/A			
N/A	Gutter Ponding?	N/A	N/A	Gutter Slope (%)	N/A
N/A	Gutter Lip Ht (in)	N/A	N/A	Gutter X Slope (%)	N/A
N/A	Painted X Walk1?	No	N/A	Painted X Walk2?	N/A
	X Walk 1 Direction	To S		X Walk 2 Direction	N/A
N/A	X Walk 1 Width (in)	N/A	N/A	X Walk 2 Width (in)	N/A
	X Walk 1 Slope (%)	1.3		X Walk 2 Slope (%)	N/A
	X Walk 1 X Slope (%)	1.2		X Walk 2 X Slope (%)	N/A

N/A	Ramp inside XWalk1?	N/A	N/A	Ramp inside XWalk2?	N/A
	Road Slope (%)	N/A	N/A	Clear Space?	N/A
	Road X Slope (%)	N/A	N/A	Clear Space to XWalk (in)	N/A
N/A	Any Obstructions?	N/A	N/A	Storm Grate/Utility Hazard?	N/A
	Obstruction Type			Storm Grate/Utility Type	
		N/A			N/A
			Yes	Surface Condition? (G/P)	Good

Remove & Replace Entire Ramp.
