Access Compliance Report

Public Rights-of-Way

(Curb Ramps)

Intersection ID: N/A	Main Street: W_W_T_HARRIS_BV	Cross Street: N/A	Location: SW
ADA ID: C521695AC1C6	Ramp Type: PerpDiag	Initial Pass/Fail: Pass	Overall Compliance: No
Codes/Mitigation Info/Possible Solution		Field Measurements/Component Compliance

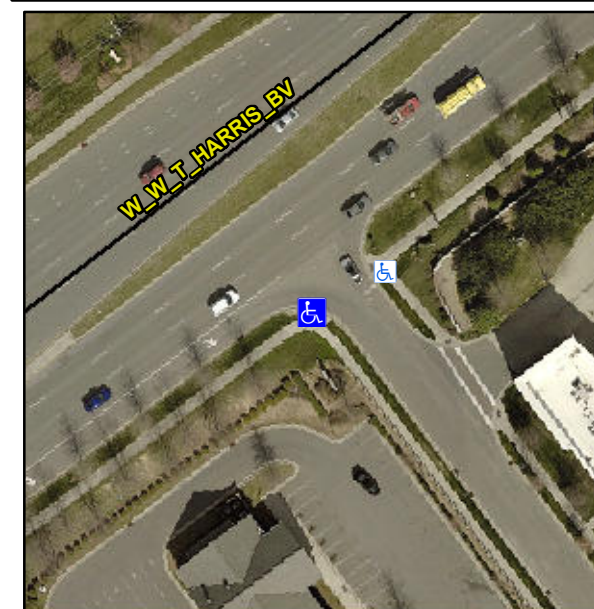
Not Found, R304.5.3, R304.2.2-Perp, R304.3.2-Para

Compliance	Description	Data	Compliance	Description	Data
N/A	Ramp Length (in)	57.0	Yes	Ramp Slope (%)	5.4
Yes	Ramp Width (in)	48.0	No	Ramp XSlope (%)	2.3
N/A	Flare Type LT	Sloped	N/A	Flare Type RT	N/A
N/A	Flare Slope LT (%)	6.3	N/A	Flare Slope RT (%)	1.6
N/A	Flare Traversable LT?	No	N/A	Flare Traversable RT?	No
Yes	Landing Length (in)	66.0	Yes	DWS Provided?	Yes
Yes	Landing Width (in)	48.0	Yes	DWS Contrast?	Yes
No	Landing Slope (%)	2.3	Yes	DWS Length (in)	24.0
No	Landing X Slope (%)	4.1	Yes	DWS Full Width?	Yes
N/A	Landing Curb? (Y/N)	No	Yes	DWS Offset (in)	1.0
N/A	Shared Landing?	No			
Yes	Gutter Ponding?	No	Yes	Gutter Slope (%)	4.3
Yes	Gutter Lip Ht (in)	0.0	Yes	Gutter X Slope (%)	0.1
N/A	Painted X Walk1?	No	N/A	Painted X Walk2?	No
	X Walk 1 Direction	To E		X Walk 2 Direction	To N
N/A	X Walk 1 Width (in)	N/A	N/A	X Walk 2 Width (in)	N/A
	X Walk 1 Slope (%)	0.4		X Walk 2 Slope (%)	2.1
	X Walk 1 X Slope (%)	1.5		X Walk 2 X Slope (%)	1.3

N/A	Ramp inside XWalk1?	N/A	N/A	Ramp inside XWalk2?	N/A
	Road Slope (%)	2.6	N/A	Clear Space?	Yes
	Road X Slope (%)	1.0	N/A	Clear Space to XWalk (in)	N/A
Yes	Any Obstructions?	No	Yes	Storm Grate/Utility Hazard?	No
	Obstruction Type			Storm Grate/Utility Type	
			N/A		N/A
			Yes	Surface Condition? (G/P)	Good

Possible Solutions:

Remove & Replace Curb Ramp With Two New Directional Ramps or Equivalent.
