Access Compliance Report

Public Rights-of-Way

(Curb Ramps)

Intersection ID: 50609	Main Street: DOWNY_BIRCH_RD	Cross Street: PADDLE_OAK_RD	Location: SE
ADA ID: C52C58624A7E	Ramp Type: Perp	Initial Pass/Fail: Pass	Overall Compliance: No
Severity Score: 0			
Codes/Mitigation Info/Possible Solution		Field Measurements/Component Compliance

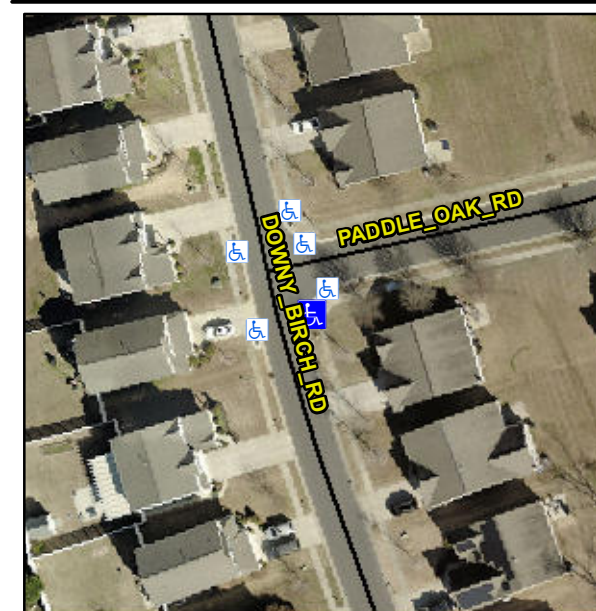
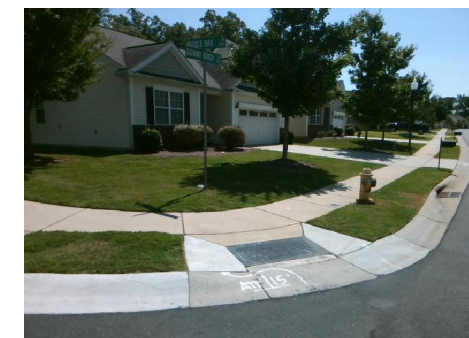
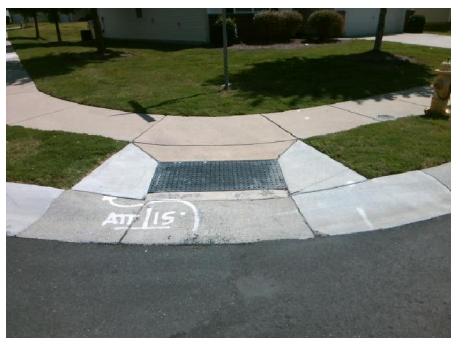
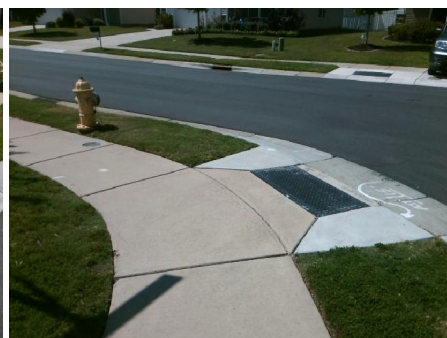
Not Found, R304.2.1, R304.2.2-Perp, R304.3.2-Para, R304.5.3, R305.2

Compliance	Description	Data	Compliance	Description	Data
N/A	Ramp Length (in)	48.0	Yes	Ramp Slope (%)	6.1
Yes	Ramp Width (in)	48.0	Yes	Ramp XSlope (%)	1.9
N/A	Flare Type LT	Sloped	N/A	Flare Type RT	N/A
N/A	Flare Slope LT (%)	10.4	N/A	Flare Slope RT (%)	4.9
N/A	Flare Traversable LT?	No	N/A	Flare Traversable RT?	No
No	Landing Length (in)	47.0	Yes	DWS Provided?	Yes
Yes	Landing Width (in)	54.5	Yes	DWS Contrast?	Yes
No	Landing Slope (%)	4.6	Yes	DWS Length (in)	24.5
No	Landing X Slope (%)	3.1	Yes	DWS Full Width?	Yes
N/A	Landing Curb? (Y/N)	No	No	DWS Offset (in)	6.5
N/A	Shared Landing?	Yes			
Yes	Gutter Ponding?	No	Yes	Gutter Slope (%)	4.4
Yes	Gutter Lip Ht (in)	0.0	Yes	Gutter X Slope (%)	2.0
N/A	Painted X Walk1?	No	N/A	Painted X Walk2?	N/A
	X Walk 1 Direction	To W		X Walk 2 Direction	N/A
N/A	X Walk 1 Width (in)	N/A	N/A	X Walk 2 Width (in)	N/A
	X Walk 1 Slope (%)	0.5		X Walk 2 Slope (%)	N/A
	X Walk 1 X Slope (%)	0.8		X Walk 2 X Slope (%)	N/A

N/A	Ramp inside XWalk1?	N/A	N/A	Ramp inside XWalk2?	N/A
	Road Slope (%)	N/A	N/A	Clear Space?	Yes
	Road X Slope (%)	N/A	N/A	Clear Space to XWalk (in)	N/A
Yes	Any Obstructions?	No	Yes	Storm Grate/Utility Hazard?	No
	Obstruction Type			Storm Grate/Utility Type	
		N/A			N/A
			Yes	Surface Condition? (G/P)	Good

Remove & Replace Entire Ramp.
