Access Compliance Report

Public Rights-of-Way

(Curb Ramps)

Intersection ID: 31688	Main Street: TRIECE_LN	Cross Street: WILLIE_WORRELL_DR	Location: E
ADA ID: C52DDC1FCFC5	Ramp Type: PerpDiag	Initial Pass/Fail: Fail	Overall Compliance: No
		Severity Score: 10

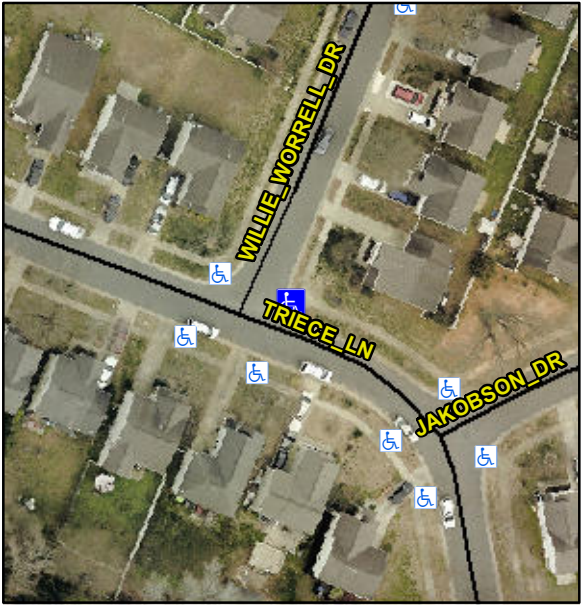
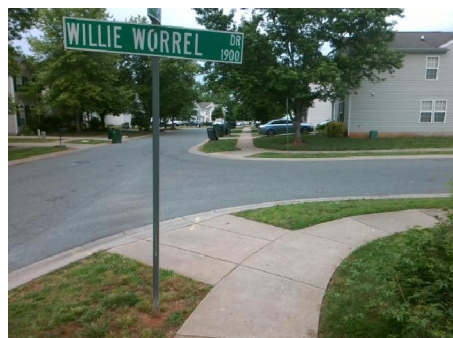
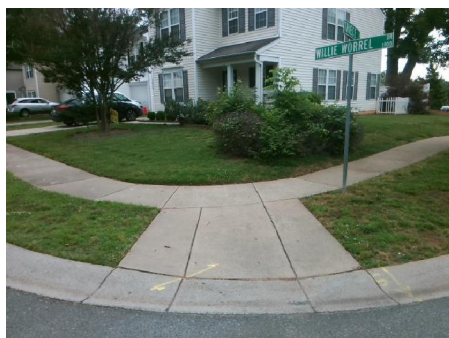
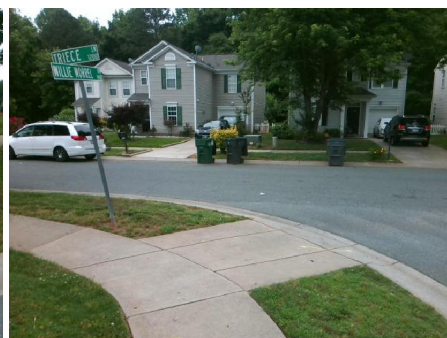
Compliance	Description	Data	Compliance	Description	Data
N/A	Ramp Length (in)	87.0	Yes	Ramp Slope (%)	7.4
No	Ramp Width (in)	40.0	No	Ramp XSlope (%)	3.2
N/A	Flare Type LT	N/A	N/A	Flare Type RT	N/A
N/A	Flare Slope LT (%)	N/A	N/A	Flare Slope RT (%)	N/A
N/A	Flare Traversable LT?	N/A	N/A	Flare Traversable RT?	N/A
N/A	Landing Length (in)	N/A	N/A	DWS Provided?	N/A
N/A	Landing Width (in)	N/A	N/A	DWS Contrast?	N/A
N/A	Landing Slope (%)	N/A	N/A	DWS Length (in)	N/A
N/A	Landing X Slope (%)	N/A	N/A	DWS Full Width?	N/A
N/A	Landing Curb? (Y/N)	N/A	N/A	DWS Offset (in)	N/A
N/A	Shared Landing?	N/A			
N/A	Gutter Ponding?	N/A	N/A	Gutter Slope (%)	N/A
N/A	Gutter Lip Ht (in)	N/A	N/A	Gutter X Slope (%)	N/A
N/A	Painted X Walk1?	No	N/A	Painted X Walk2?	No
	X Walk 1 Direction	To NW		X Walk 2 Direction	To SW
N/A	X Walk 1 Width (in)	N/A	N/A	X Walk 2 Width (in)	N/A
	X Walk 1 Slope (%)	2.2		X Walk 2 Slope (%)	3.7
	X Walk 1 X Slope (%)	0.3		X Walk 2 X Slope (%)	2.3

N/A	Ramp inside XWalk1?	N/A	N/A	Ramp inside XWalk2?	N/A
	Road Slope (%)	0.8	N/A	Clear Space?	N/A
	Road X Slope (%)	1.6	N/A	Clear Space to XWalk (in)	N/A
N/A	Any Obstructions?	N/A	N/A	Storm Grate/Utility Hazard?	N/A
	Obstruction Type			Storm Grate/Utility Type	
		N/A			N/A
			Yes	Surface Condition? (G/P)	Good

Possible Solutions:				
	Remove & Replace Curb Ramp With Two New Directional Ramps or Equivalent.				
	Surveyor Notes:				
	N/A				
	PROW/ADA:				
	R304.5.1, R304.5.3				
Street 1 Name	WILLIE WORRELL DR				
Stop Condition-Street 2	StopSign				
Street 2 Name	TRIECE LN				
Stop Condition-Street 1	None				
Total Cost:		\$	3200.00
