Access Compliance Report

Public Rights-of-Way

(Curb Ramps)

| Intersection ID: 10025869 | Main Street: ELEVATION_POINT_DR | Cross Street: N/A | Location: NW |

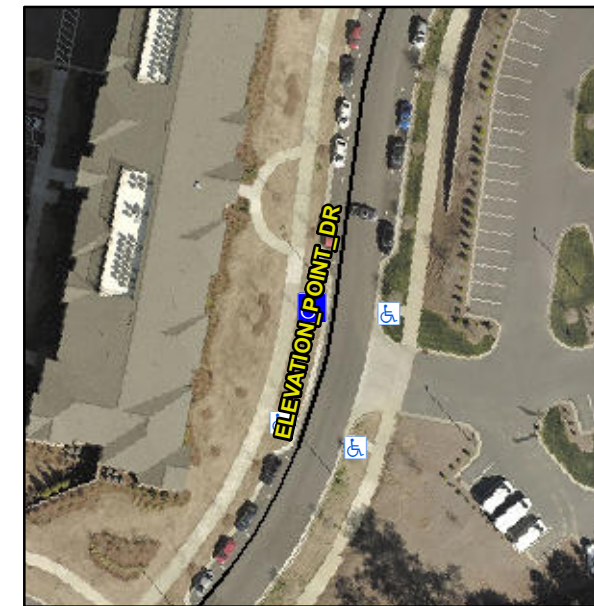
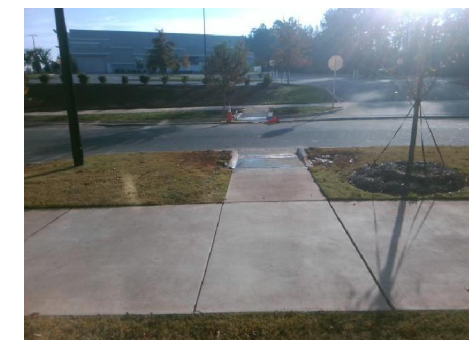
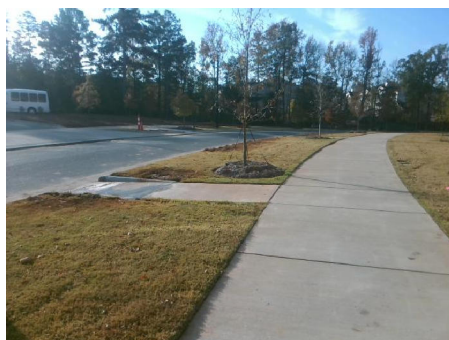
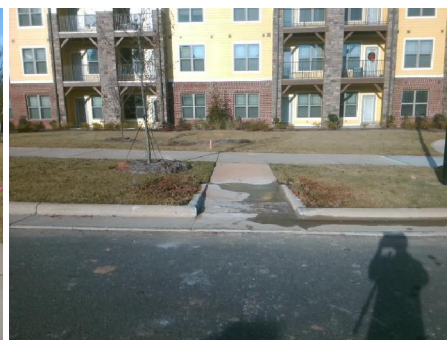
| ADA ID: C53ACA698C68 | Ramp Type: Perp | Initial Pass/Fail: Pass | Overall Compliance: No |

Not Found, R304.5.3, R304.5.4

| Compliance | Description | Data | Compliance | Description | Data |
|---|---|---|---|---|---|
| Yes | Ramp Width (in) | 60.0 | No | Ramp XSlope (%) | 3.2 |
| No | Landing X Slope (%) | 3.3 | Yes | DWS Full Width? | Yes |
| Yes | Gutter Ponding? | No | No | Gutter Slope (%) | 5.4 |

**Remove & Replace Entire Ramp.
Remove & Replace Gutter.**
