Access Compliance Report

Public Rights-of-Way

(Curb Ramps)

Intersection ID: 12830	Main Street: CARYA_POND_LN	Cross Street: HICKORY_GROVE_RD	Location: SE
ADA ID: C54E59D4FAD5	Ramp Type: Perp	Initial Pass/Fail: Fail	Overall Compliance: No
		Severity Score: 10

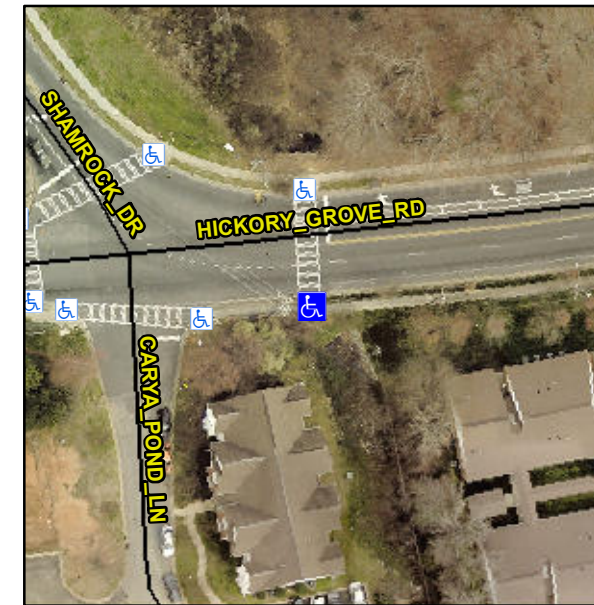
Not Found, R304.5.1, R304.5.3

Compliance	Description	Data	Compliance	Description	Data
N/A	Ramp Length (in)	48.0	Yes	Ramp Slope (%)	8.1
No	Ramp Width (in)	46.0	No	Ramp XSlope (%)	2.9
N/A	Flare Type LT	N/A	N/A	Flare Type RT	N/A
N/A	Flare Slope LT (%)	N/A	N/A	Flare Slope RT (%)	N/A
N/A	Flare Traversable LT?	N/A	N/A	Flare Traversable RT?	N/A
N/A	Landing Length (in)	N/A	N/A	DWS Provided?	N/A
N/A	Landing Width (in)	N/A	N/A	DWS Contrast?	N/A
N/A	Landing Slope (%)	N/A	N/A	DWS Length (in)	N/A
N/A	Landing X Slope (%)	N/A	N/A	DWS Full Width?	N/A
N/A	Landing Curb? (Y/N)	N/A	N/A	DWS Offset (in)	N/A
N/A	Shared Landing?	N/A			
N/A	Gutter Ponding?	N/A	N/A	Gutter Slope (%)	N/A
N/A	Gutter Lip Ht (in)	N/A	N/A	Gutter X Slope (%)	N/A
N/A	Painted X Walk1?	Yes	N/A	Painted X Walk2?	N/A
	X Walk 1 Direction	To N		X Walk 2 Direction	N/A
N/A	X Walk 1 Width (in)	119.0	N/A	X Walk 2 Width (in)	N/A
	X Walk 1 Slope (%)	1.5		X Walk 2 Slope (%)	N/A
	X Walk 1 X Slope (%)	1.2		X Walk 2 X Slope (%)	N/A

N/A	Ramp inside XWalk1?	Yes	N/A	Ramp inside XWalk2?	N/A
	Road Slope (%)	N/A	N/A	Clear Space?	N/A
	Road X Slope (%)	N/A	N/A	Clear Space to XWalk (in)	N/A
N/A	Any Obstructions?	N/A	N/A	Storm Grate/Utility Hazard?	N/A
	Obstruction Type			Storm Grate/Utility Type	
		N/A			N/A
			Yes	Surface Condition? (G/P)	Good

Remove & Replace Entire Ramp.
