# Access Compliance Report

## Public Rights-of-Way

### (Curb Ramps)

| Intersection ID: 11084 | Main Street: E_25TH_ST | Cross Street: EVERETT_PL | Location: S |

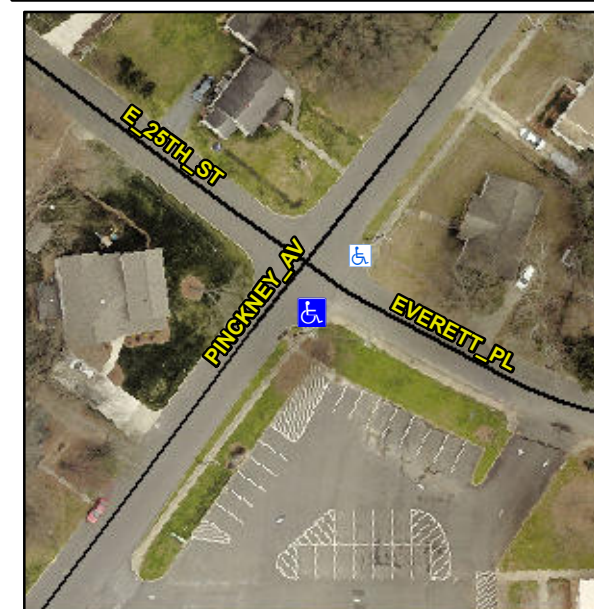
**Not Found, R304.5.1, R304.2.2**

| Compliance | Description | Data | Compliance | Description | Data |
|---|---|---|---|---|---|
| N/A | Ramp Length (in) | 62.0 | No | Ramp Slope (%) | 8.4 |
| No | Ramp Width (in) | 40.0 | Yes | Ramp XSlope (%) | 1.4 |

**Remove & Replace Entire Ramp.**

Total Cost: \$ 1850.00
