Access Compliance Report

Public Rights-of-Way

(Curb Ramps)

Intersection ID: 29131	Main Street: ALDERPOINT_LN	Cross Street: ANGWIN_PL	Location: NE
ADA ID: C558FAB0D1A7	Ramp Type: BlendTrans1	Initial Pass/Fail: Pass	Overall Compliance: No
Severity Score: 10			
Codes/Mitigation Info/Possible Solution		Field Measurements/Component Compliance

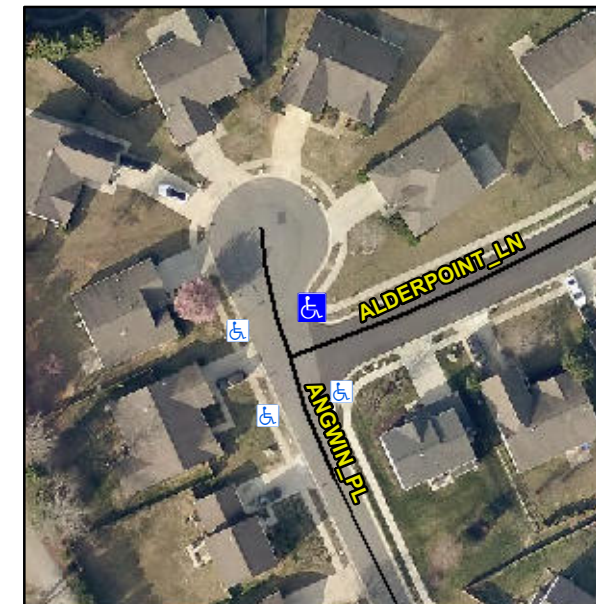
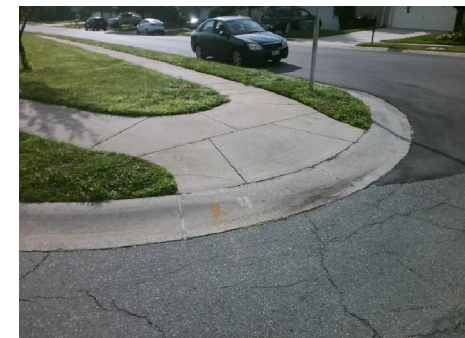
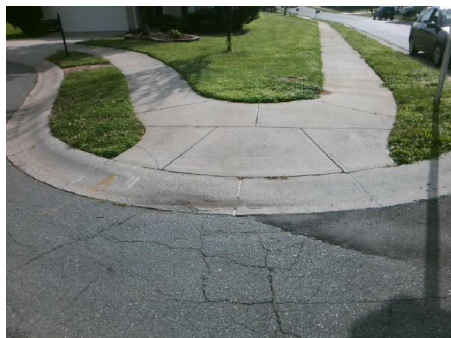
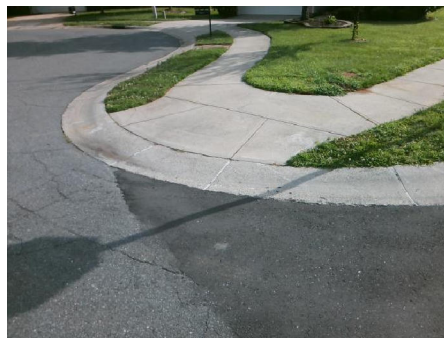
Not Found, R304.2.1, R304.2.2-Perp, R304.3.2-Para, R304.5.3, R305, R302.7

Compliance	Description	Data	Compliance	Description	Data
N/A	Ramp Length (in)	51.0	Yes	BlendTrans Slope (%)	2.7
Yes	Ramp Width (in)	120.0	Yes	BlendTrans XSlope (%)	0.6
N/A	Flare Type LT	Sloped	N/A	Flare Type RT	Sloped
N/A	Flare Slope LT (%)	1.0	N/A	Flare Slope RT (%)	1.5
N/A	Flare Traversable LT?	No	N/A	Flare Traversable RT?	No
No	Landing Length (in)	43.0	No	DWS Provided?	No
Yes	Landing Width (in)	84.0	N/A	DWS Contrast?	No
No	Landing Slope (%)	2.1	N/A	DWS Length (in)	N/A
No	Landing X Slope (%)	2.6	N/A	DWS Full Width?	No
N/A	Landing Curb? (Y/N)	No	N/A	DWS Offset (in)	N/A
N/A	Shared Landing?	No			
No	Gutter Ponding?	Yes	Yes	Gutter Slope (%)	3.1
Yes	Gutter Lip Ht (in)	0.0	Yes	Gutter X Slope (%)	1.9
N/A	Painted X Walk1?	No	N/A	Painted X Walk2?	No
	X Walk 1 Direction	To SW		X Walk 2 Direction	To SE
	X Walk 1 Width (in)	N/A		X Walk 2 Width (in)	N/A
	X Walk 1 Slope (%)	5.5		X Walk 2 Slope (%)	1.2
	X Walk 1 X Slope (%)	0.8		X Walk 2 X Slope (%)	5.5

N/A	Ramp inside XWalk1?	N/A	N/A	Ramp inside XWalk2?	N/A
	Road Slope (%)	0.1		Clear Space?	Yes
	Road X Slope (%)	5.7	N/A	Clear Space to XWalk (in)	N/A
Yes	Any Obstructions?	No	Yes	Storm Grate/Utility Hazard?	No
	Obstruction Type			Storm Grate/Utility Type	
		N/A			N/A
			Yes	Surface Condition? (G/P)	Good
			No	Curb Slope (%)	14.4

Remove & Replace Curb Ramp With Two New Directional Ramps or Equivalent.
