Access Compliance Report

Public Rights-of-Way

(Curb Ramps)

Intersection ID: 31419	Main Street: CORNELIA_DR	Cross Street: OLD_WAGON_RD	Location: SE
ADA ID: C55BA9069686	Ramp Type: Perp	Initial Pass/Fail: Fail	Overall Compliance: No
Severity Score: 22.5			
Codes/Mitigation Info/Possible Solution		Field Measurements/Component Compliance

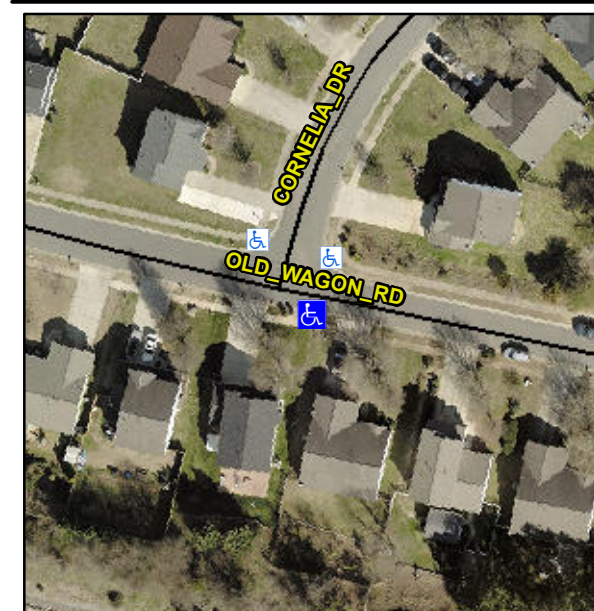
Not Found, R304.5.1, R304.2.2

Compliance	Description	Data	Compliance	Description	Data
N/A	Ramp Length (in)	46.5	No	Ramp Slope (%)	10.0
No	Ramp Width (in)	47.0	Yes	Ramp XSlope (%)	2.9
N/A	Flare Type LT	N/A	N/A	Flare Type RT	N/A
N/A	Flare Slope LT (%)	N/A	N/A	Flare Slope RT (%)	N/A
N/A	Flare Traversable LT?	N/A	N/A	Flare Traversable RT?	N/A
N/A	Landing Length (in)	N/A	N/A	DWS Provided?	N/A
N/A	Landing Width (in)	N/A	N/A	DWS Contrast?	N/A
N/A	Landing Slope (%)	N/A	N/A	DWS Length (in)	N/A
N/A	Landing X Slope (%)	N/A	N/A	DWS Full Width?	N/A
N/A	Landing Curb? (Y/N)	N/A	N/A	DWS Offset (in)	N/A
N/A	Shared Landing?	N/A			
N/A	Gutter Ponding?	N/A	N/A	Gutter Slope (%)	N/A
N/A	Gutter Lip Ht (in)	N/A	N/A	Gutter X Slope (%)	N/A
N/A	Painted X Walk1?	No	N/A	Painted X Walk2?	N/A
	X Walk 1 Direction	To NE		X Walk 2 Direction	N/A
N/A	X Walk 1 Width (in)	N/A	N/A	X Walk 2 Width (in)	N/A
	X Walk 1 Slope (%)	0.4		X Walk 2 Slope (%)	N/A
	X Walk 1 X Slope (%)	3.1		X Walk 2 X Slope (%)	N/A

N/A	Ramp inside XWalk1?	N/A	N/A	Ramp inside XWalk2?	N/A
	Road Slope (%)	N/A	N/A	Clear Space?	N/A
	Road X Slope (%)	N/A	N/A	Clear Space to XWalk (in)	N/A
N/A	Any Obstructions?	N/A	N/A	Storm Grate/Utility Hazard?	N/A
	Obstruction Type			Storm Grate/Utility Type	
		N/A			N/A
			Yes	Surface Condition? (G/P)	Good

Possible Solutions:

Remove & Replace Entire Ramp.
