Access Compliance Report

Public Rights-of-Way

(Curb Ramps)

Intersection ID: 11676	Main Street: HAWTHORNE_LN	Cross Street: PARKWOOD_AV	Location: SW
ADA ID: C56CC81041E1	Ramp Type: Perp	Initial Pass/Fail: Fail	Overall Compliance: No
		Severity Score: 10

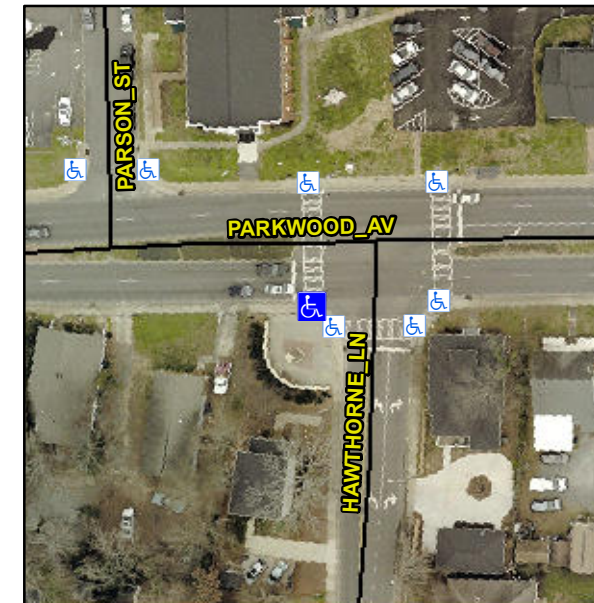
Not Found, R304.5.1, R304.5.3

Compliance	Description	Data	Compliance	Description	Data
N/A	Ramp Length (in)	49.0	Yes	Ramp Slope (%)	7.2
No	Ramp Width (in)	47.0	No	Ramp XSlope (%)	3.7
N/A	Flare Type LT	N/A	N/A	Flare Type RT	N/A
N/A	Flare Slope LT (%)	N/A	N/A	Flare Slope RT (%)	N/A
N/A	Flare Traversable LT?	N/A	N/A	Flare Traversable RT?	N/A
N/A	Landing Length (in)	N/A	N/A	DWS Provided?	N/A
N/A	Landing Width (in)	N/A	N/A	DWS Contrast?	N/A
N/A	Landing Slope (%)	N/A	N/A	DWS Length (in)	N/A
N/A	Landing X Slope (%)	N/A	N/A	DWS Full Width?	N/A
N/A	Landing Curb? (Y/N)	N/A	N/A	DWS Offset (in)	N/A
N/A	Shared Landing?	N/A			
N/A	Gutter Ponding?	N/A	N/A	Gutter Slope (%)	N/A
N/A	Gutter Lip Ht (in)	N/A	N/A	Gutter X Slope (%)	N/A
N/A	Painted X Walk1?	Yes	N/A	Painted X Walk2?	N/A
	X Walk 1 Direction	To N		X Walk 2 Direction	N/A
N/A	X Walk 1 Width (in)	103.0	N/A	X Walk 2 Width (in)	N/A
	X Walk 1 Slope (%)	1.1		X Walk 2 Slope (%)	N/A
	X Walk 1 X Slope (%)	3.5		X Walk 2 X Slope (%)	N/A

Remove & Replace Entire Ramp.
