Access Compliance Report

Public Rights-of-Way

(Curb Ramps)

Intersection ID: 10644	Main Street: FRAZIER_AV	Cross Street: MARTIN_ST	Location: E
ADA ID: C571CE FCC794	Ramp Type: Perp	Initial Pass/Fail: Fail	Overall Compliance: No
Severity Score: 21.25			
Codes/Mitigation Info/Possible Solution		Field Measurements/Component Compliance

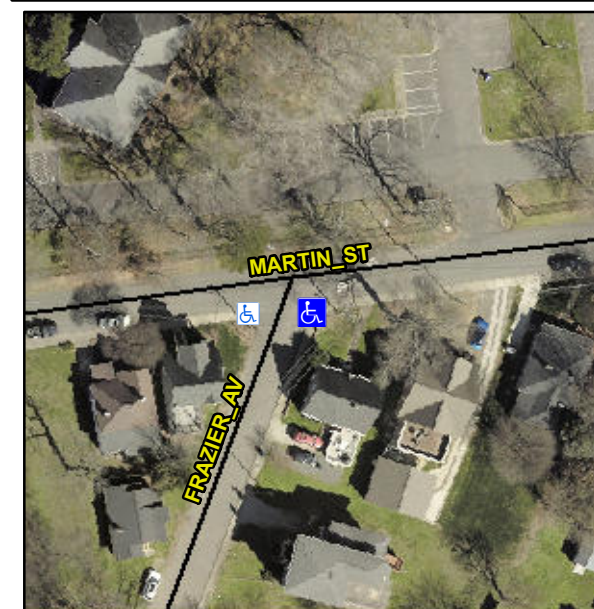
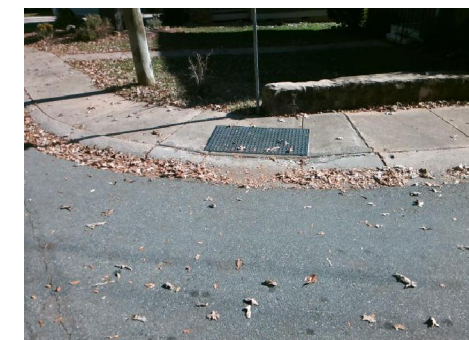
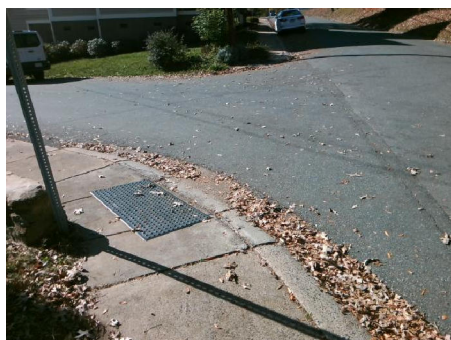
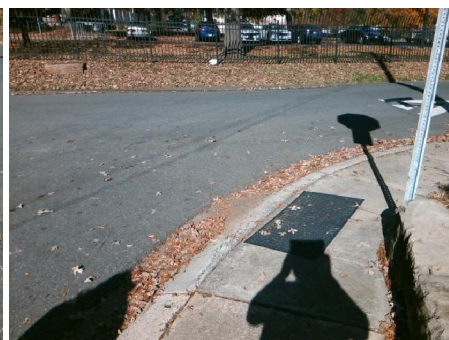
Not Found, R304.5.1, R304.2.2

Compliance	Description	Data	Compliance	Description	Data
N/A	Ramp Length (in)	45.0	No	Ramp Slope (%)	8.7
No	Ramp Width (in)	41.5	Yes	Ramp XSlope (%)	0.4
N/A	Flare Type LT	N/A	N/A	Flare Type RT	N/A
N/A	Flare Slope LT (%)	N/A	N/A	Flare Slope RT (%)	N/A
N/A	Flare Traversable LT?	N/A	N/A	Flare Traversable RT?	N/A
N/A	Landing Length (in)	N/A	N/A	DWS Provided?	N/A
N/A	Landing Width (in)	N/A	N/A	DWS Contrast?	N/A
N/A	Landing Slope (%)	N/A	N/A	DWS Length (in)	N/A
N/A	Landing X Slope (%)	N/A	N/A	DWS Full Width?	N/A
N/A	Landing Curb? (Y/N)	N/A	N/A	DWS Offset (in)	N/A
N/A	Shared Landing?	N/A			
N/A	Gutter Ponding?	N/A	N/A	Gutter Slope (%)	N/A
N/A	Gutter Lip Ht (in)	0.5	N/A	Gutter X Slope (%)	N/A
N/A	Painted X Walk1?	No	N/A	Painted X Walk2?	N/A
	X Walk 1 Direction	To W		X Walk 2 Direction	N/A
N/A	X Walk 1 Width (in)	N/A	N/A	X Walk 2 Width (in)	N/A
	X Walk 1 Slope (%)	6.7		X Walk 2 Slope (%)	N/A
	X Walk 1 X Slope (%)	5.0		X Walk 2 X Slope (%)	N/A

N/A	Ramp inside XWalk1?	N/A	N/A	Ramp inside XWalk2?	N/A
	Road Slope (%)	N/A	N/A	Clear Space?	N/A
	Road X Slope (%)	N/A	N/A	Clear Space to XWalk (in)	N/A
N/A	Any Obstructions?	N/A	N/A	Storm Grate/Utility Hazard?	N/A
	Obstruction Type			Storm Grate/Utility Type	
		N/A			N/A
			Yes	Surface Condition? (G/P)	Good

Remove & Replace Entire Ramp.
