Access Compliance Report

Public Rights-of-Way

(Curb Ramps)

Intersection ID: 27363	Main Street: REA_RD	Cross Street: BALLANTYNE_COMMONS_PY	Location: NW
ADA ID: C582484330C2	Ramp Type: Perp	Initial Pass/Fail: Fail	Overall Compliance: No
Severity Score: 13.75			
Codes/Mitigation Info/Possible Solution		Field Measurements/Component Compliance

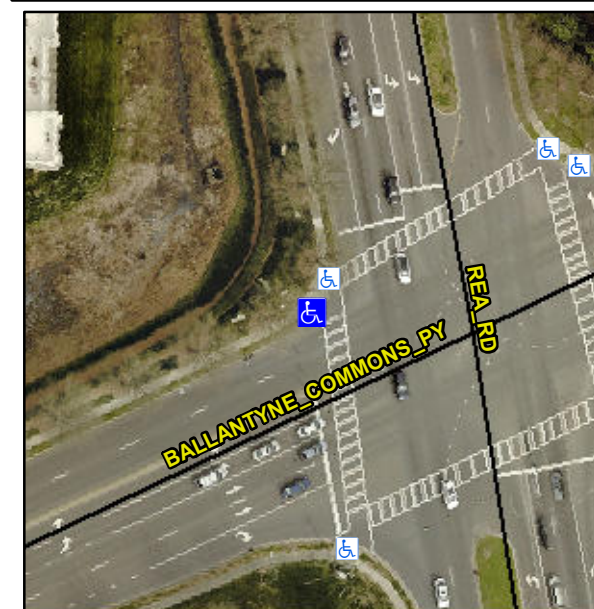
Not Found, R304.2.2, R304.5.3

Compliance	Description	Data	Compliance	Description	Data
N/A	Ramp Length (in)	107.0	No	Ramp Slope (%)	11.1
Yes	Ramp Width (in)	51.0	No	Ramp XSlope (%)	3.6
N/A	Flare Type LT	N/A	N/A	Flare Type RT	N/A
N/A	Flare Slope LT (%)	N/A	N/A	Flare Slope RT (%)	N/A
N/A	Flare Traversable LT?	N/A	N/A	Flare Traversable RT?	N/A
N/A	Landing Length (in)	N/A	N/A	DWS Provided?	N/A
N/A	Landing Width (in)	N/A	N/A	DWS Contrast?	N/A
N/A	Landing Slope (%)	N/A	N/A	DWS Length (in)	N/A
N/A	Landing X Slope (%)	N/A	N/A	DWS Full Width?	N/A
N/A	Landing Curb? (Y/N)	N/A	N/A	DWS Offset (in)	N/A
N/A	Shared Landing?	N/A			
N/A	Gutter Ponding?	N/A	N/A	Gutter Slope (%)	N/A
N/A	Gutter Lip Ht (in)	N/A	N/A	Gutter X Slope (%)	N/A
N/A	Painted X Walk1?	Yes	N/A	Painted X Walk2?	N/A
	X Walk 1 Direction	To S		X Walk 2 Direction	N/A
N/A	X Walk 1 Width (in)	126.0	N/A	X Walk 2 Width (in)	N/A
	X Walk 1 Slope (%)	3.1		X Walk 2 Slope (%)	N/A
	X Walk 1 X Slope (%)	0.9		X Walk 2 X Slope (%)	N/A

N/A	Ramp inside XWalk1?	No	N/A	Ramp inside XWalk2?	N/A
	Road Slope (%)	N/A	N/A	Clear Space?	N/A
	Road X Slope (%)	N/A	N/A	Clear Space to XWalk (in)	N/A
N/A	Any Obstructions?	N/A	N/A	Storm Grate/Utility Hazard?	N/A
	Obstruction Type			Storm Grate/Utility Type	
		N/A			N/A
		Yes		Surface Condition? (G/P)	Good

Possible Solutions:

**Remove & Replace Entire Ramp.
Restripe Crosswalk.**
