## **Access Compliance Report Public Rights-of-Way** (Curb Ramps)

Intersection ID: 54365 Main Street: COLLINS\_FORD\_RD Cross Street: GANNON\_DR Location: N **Overall Compliance: No** ADA ID: C582B26866CF Ramp Type: Perp Initial Pass/Fail: Fail **Severity Score:** 12.5

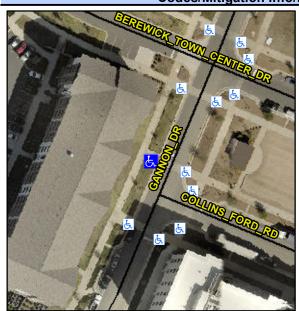
Field Measurements/Component Compliance						
Compliance Description		Data	Comp	oliance Description	Data	
N/A	Ramp Length (in)	72.0	No	Ramp Slope (%)	9.3	
Yes	Ramp Width (in)	94.5	Yes	Ramp XSlope (%)	0.1	
N/A	Flare Type LT	N/A	N/A	Flare Type RT	N/A	
N/A	Flare Slope LT (%)	N/A	N/A	Flare Slope RT (%)	N/A	
N/A	Flare Traversable LT?	N/A	N/A	Flare Traversable RT?	N/A	
N/A	Landing Length (in)	N/A	N/A	DWS Provided?	N/A	
N/A	Landing Width (in)	N/A	N/A	DWS Contrast?	N/A	
N/A	Landing Slope (%)	N/A	N/A	DWS Length (in)	N/A	
N/A	Landing X Slope (%)	N/A	N/A	DWS Full Width?	N/A	
N/A	Landing Curb? (Y/N)	N/A	N/A	DWS Offset (in)	N/A	
N/A	Shared Landing?	N/A				
N/A	Gutter Ponding?	N/A	N/A	Gutter Slope (%)	N/A	
N/A	Gutter Lip Ht (in)	N/A	N/A	Gutter X Slope (%)	N/A	
N/A	Painted X Walk1?	Yes	N/A	Painted X Walk2?	N/A	
	X Walk 1 Direction	To SE		X Walk 2 Direction	N/A	
N/A	X Walk 1 Width (in)	97.5	N/A	X Walk 2 Width (in)	N/A	
	X Walk 1 Slope (%)	2.8		X Walk 2 Slope (%)	N/A

1 Caarbie Colution					
Possible Solutions:					
Remove & Replace Entire Ramp.					
Surveyor Notes:					
N/A					
PROW/ADA:					
R304.2.2
