Access Compliance Report

Public Rights-of-Way

(Curb Ramps)

Intersection ID: 53534	Main Street: N_JOSH_BIRMINGHAM_PY	Cross Street: WILKINSON_BV	Location: SW
ADA ID: C58B8A8358F5	Ramp Type: BlendTrans1	Initial Pass/Fail: Fail	Overall Compliance: No
Codes/Mitigation Info/Possible Solution		Field Measurements/Component Compliance	
Severity Score: 21.25

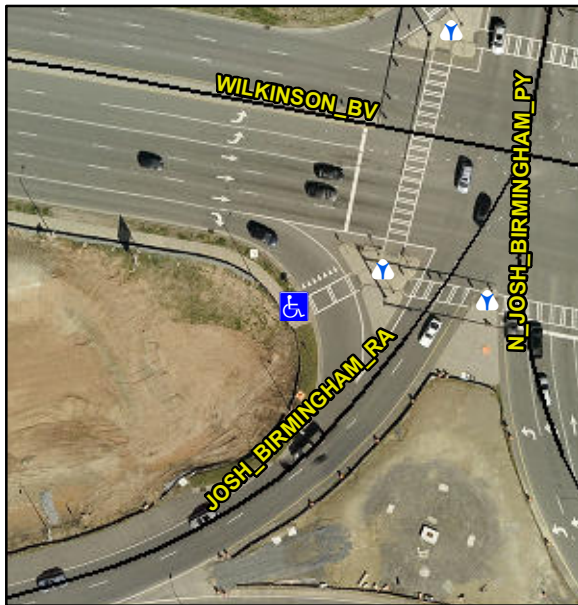
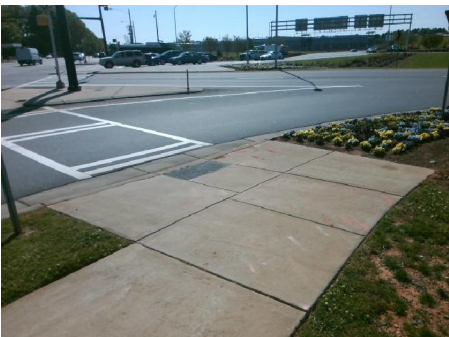
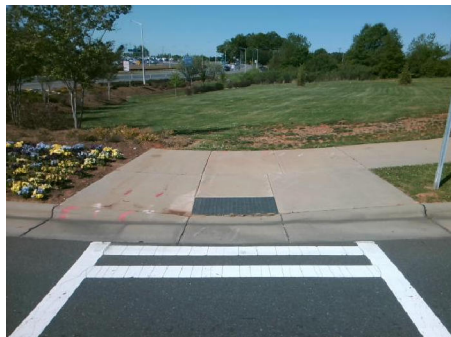
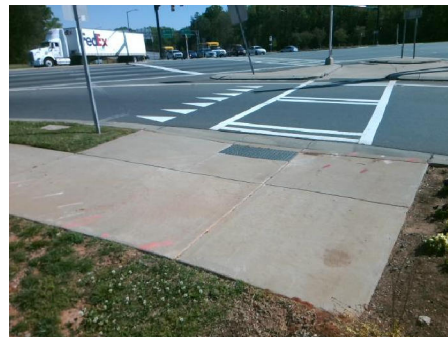
RP & LT RP < 5%

R304.5.1, R304.5.3

Compliance	Description	Data	Compliance	Description	Data
N/A	Ramp Length (in)	67.0	Yes	BlendTrans Slope (%)	3.6
No	Ramp Width (in)	46.5	No	BlendTrans XSlope (%)	6.2
N/A	Flare Type LT	N/A	N/A	Flare Type RT	N/A
N/A	Flare Slope LT (%)	N/A	N/A	Flare Slope RT (%)	N/A
N/A	Flare Traversable LT?	N/A	N/A	Flare Traversable RT?	N/A
N/A	Landing Length (in)	N/A	N/A	DWS Provided?	N/A
N/A	Landing Width (in)	N/A	N/A	DWS Contrast?	N/A
N/A	Landing Slope (%)	N/A	N/A	DWS Length (in)	N/A
N/A	Landing X Slope (%)	N/A	N/A	DWS Full Width?	N/A
N/A	Landing Curb? (Y/N)	N/A	N/A	DWS Offset (in)	N/A
N/A	Shared Landing?	N/A			
N/A	Gutter Ponding?	N/A	N/A	Gutter Slope (%)	N/A
N/A	Gutter Lip Ht (in)	N/A	N/A	Gutter X Slope (%)	N/A
N/A	Painted X Walk1?	Yes	N/A	Painted X Walk2?	N/A
	X Walk 1 Direction	To NE		X Walk 2 Direction	N/A
	X Walk 1 Width (in)	109.0		X Walk 2 Width (in)	N/A
	X Walk 1 Slope (%)	3.8		X Walk 2 Slope (%)	N/A
	X Walk 1 X Slope (%)	4.7		X Walk 2 X Slope (%)	N/A

N/A	Ramp inside XWalk1?	Yes	N/A	Ramp inside XWalk2?	N/A
	Road Slope (%)	4.7		Clear Space?	N/A
	Road X Slope (%)	3.8	N/A	Clear Space to XWalk (in)	N/A
N/A	Any Obstructions?	N/A	N/A	Storm Grate/Utility Hazard?	N/A
	Obstruction Type			Storm Grate/Utility Type	
		N/A			N/A
			Yes	Surface Condition? (G/P)	Good
			N/A	Curb Slope (%)	2.8

Possible Solutions:

Remove & Replace Curb Ramp With Two New Directional Ramps or Equivalent.

Total Cost: \$ **3200.00**
