Access Compliance Report

Public Rights-of-Way

(Curb Ramps)

Intersection ID: 5421	Main Street: SUNSET_RD	Cross Street: OLD_STATESVILLE_RD	Location: E
ADA ID: C58FCEFD6F3C	Ramp Type: Perp	Initial Pass/Fail: Fail	Overall Compliance: No
		Severity Score: 12.5

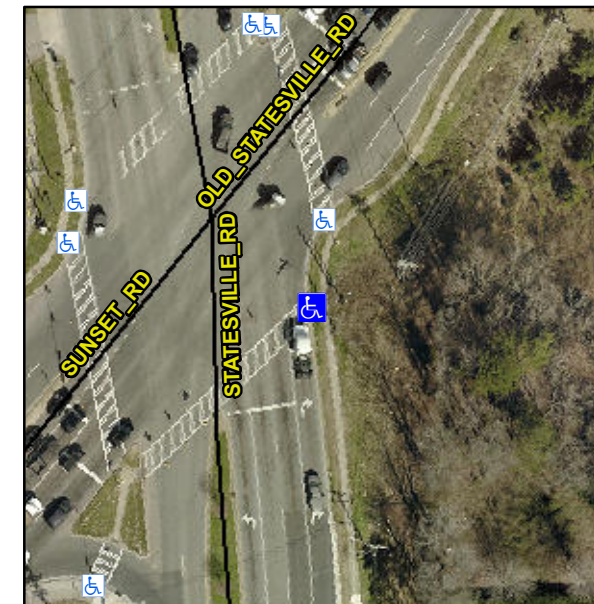
Not Found, R304.2.2

Compliance	Description	Data	Compliance	Description	Data
N/A	Ramp Length (in)	60.0	No	Ramp Slope (%)	10.6
Yes	Ramp Width (in)	48.0	Yes	Ramp XSlope (%)	0.4
N/A	Flare Type LT	N/A	N/A	Flare Type RT	N/A
N/A	Flare Slope LT (%)	N/A	N/A	Flare Slope RT (%)	N/A
N/A	Flare Traversable LT?	N/A	N/A	Flare Traversable RT?	N/A
N/A	Landing Length (in)	N/A	N/A	DWS Provided?	N/A
N/A	Landing Width (in)	N/A	N/A	DWS Contrast?	N/A
N/A	Landing Slope (%)	N/A	N/A	DWS Length (in)	N/A
N/A	Landing X Slope (%)	N/A	N/A	DWS Full Width?	N/A
N/A	Landing Curb? (Y/N)	N/A	N/A	DWS Offset (in)	N/A
N/A	Shared Landing?	N/A			
N/A	Gutter Ponding?	N/A	N/A	Gutter Slope (%)	N/A
N/A	Gutter Lip Ht (in)	N/A	N/A	Gutter X Slope (%)	N/A
N/A	Painted X Walk1?	Yes	N/A	Painted X Walk2?	N/A
	X Walk 1 Direction	To SW		X Walk 2 Direction	N/A
N/A	X Walk 1 Width (in)	142.0	N/A	X Walk 2 Width (in)	N/A
	X Walk 1 Slope (%)	3.7		X Walk 2 Slope (%)	N/A
	X Walk 1 X Slope (%)	2.2		X Walk 2 X Slope (%)	N/A

N/A	Ramp inside XWalk1?	Yes	N/A	Ramp inside XWalk2?	N/A
	Road Slope (%)	N/A	N/A	Clear Space?	N/A
	Road X Slope (%)	N/A	N/A	Clear Space to XWalk (in)	N/A
N/A	Any Obstructions?	N/A	N/A	Storm Grate/Utility Hazard?	N/A
	Obstruction Type			Storm Grate/Utility Type	
		N/A			N/A
			Yes	Surface Condition? (G/P)	Good

Remove & Replace Entire Ramp.

Total Cost: \$ 1850.00
