# Access Compliance Report

## Public Rights-of-Way

### (Curb Ramps)

Intersection ID: 17925	Main Street: CROSS_WINDS_RD	Cross Street: IDLEWILD_RD	Location:	E
ADA ID: C59B9DE2CBF2	Ramp Type: BlendTrans2	Initial Pass/Fail: Fail	Overall Compliance: No	Severity Score: 10

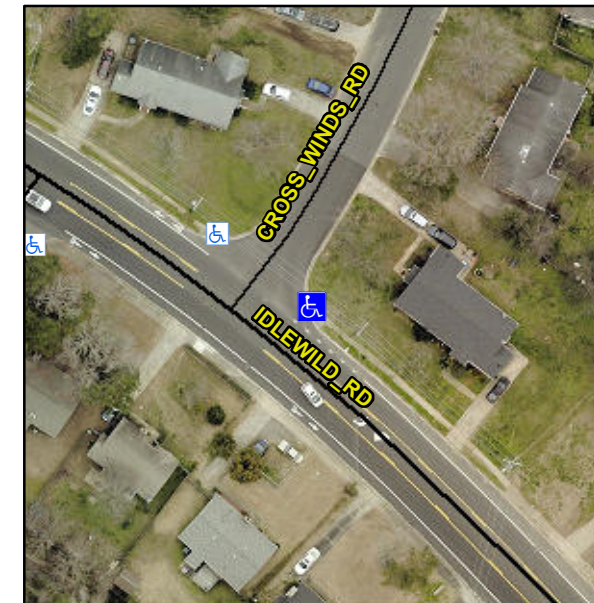
**Not Found, R304.5.1, R304.5.3**

Compliance	Description	Data	Compliance	Description	Data
N/A	Ramp Length (in)	54.0	Yes	BlendTrans Slope (%)	2.8
No	Ramp Width (in)	47.0	No	BlendTrans XSlope (%)	3.5
N/A	Flare Type LT	N/A	N/A	Flare Type RT	N/A
N/A	Flare Slope LT (%)	N/A	N/A	Flare Slope RT (%)	N/A
N/A	Flare Traversable LT?	N/A	N/A	Flare Traversable RT?	N/A
N/A	Landing Length (in)	N/A	N/A	DWS Provided?	N/A
N/A	Landing Width (in)	N/A	N/A	DWS Contrast?	N/A
N/A	Landing Slope (%)	N/A	N/A	DWS Length (in)	N/A
N/A	Landing X Slope (%)	N/A	N/A	DWS Full Width?	N/A
N/A	Landing Curb? (Y/N)	N/A	N/A	DWS Offset (in)	N/A
N/A	Shared Landing?	N/A			
N/A	Gutter Ponding?	N/A	N/A	Gutter Slope (%)	N/A
N/A	Gutter Lip Ht (in)	N/A	N/A	Gutter X Slope (%)	N/A
N/A	Painted X Walk1?	No	N/A	Painted X Walk2?	No
	X Walk 1 Direction	To NW		X Walk 2 Direction	To SW
	X Walk 1 Width (in)	N/A		X Walk 2 Width (in)	N/A
	X Walk 1 Slope (%)	5.2		X Walk 2 Slope (%)	0.4
	X Walk 1 X Slope (%)	0.9		X Walk 2 X Slope (%)	3.1

N/A	Ramp inside XWalk1?	N/A	N/A	Ramp inside XWalk2?	N/A
	Road Slope (%)	3.5		Clear Space?	N/A
	Road X Slope (%)	4.4	N/A	Clear Space to XWalk (in)	N/A
N/A	Any Obstructions?	N/A	N/A	Storm Grate/Utility Hazard?	N/A
	Obstruction Type			Storm Grate/Utility Type	
		N/A			N/A
			Yes	Surface Condition? (G/P)	Good
			No	Curb Slope (%)	19.3

**Remove & Replace Curb Ramp With Two New Directional Ramps or Equivalent.**
