Access Compliance Report

Public Rights-of-Way

(Curb Ramps)

Intersection ID: 14645	Main Street: DILWORTH RD WEST	Cross Street: E PARK AV	Location:	N
ADA ID: C5A2080FBF82	Ramp Type: PerpDiag	Initial Pass/Fail: Fail	Overall Compliance: No	Severity Score: 37.5
Codes/Mitigation Info/Possible Solution		Field Measurements/Component Compliance

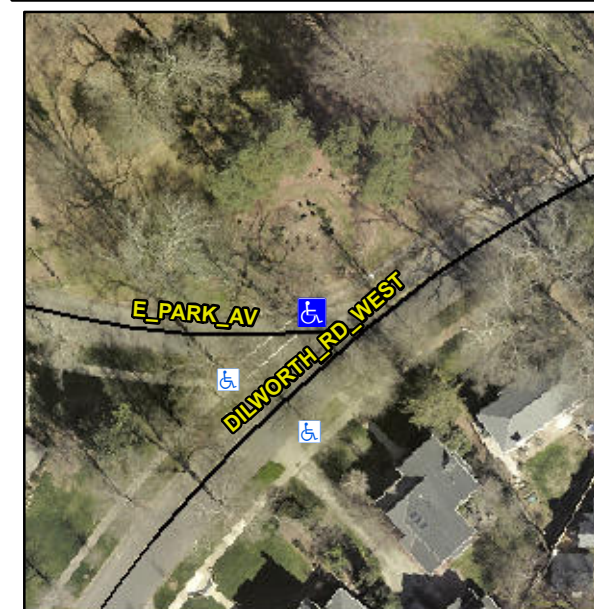
Not Found, R304.2.2, R304.5.3

Compliance	Description	Data	Compliance	Description	Data
N/A	Ramp Length (in)	51.0	No	Ramp Slope (%)	22.1
Yes	Ramp Width (in)	72.0	No	Ramp XSlope (%)	5.6
N/A	Flare Type LT	N/A	N/A	Flare Type RT	N/A
N/A	Flare Slope LT (%)	N/A	N/A	Flare Slope RT (%)	N/A
N/A	Flare Traversable LT?	N/A	N/A	Flare Traversable RT?	N/A
N/A	Landing Length (in)	N/A	N/A	DWS Provided?	N/A
N/A	Landing Width (in)	N/A	N/A	DWS Contrast?	N/A
N/A	Landing Slope (%)	N/A	N/A	DWS Length (in)	N/A
N/A	Landing X Slope (%)	N/A	N/A	DWS Full Width?	N/A
N/A	Landing Curb? (Y/N)	N/A	N/A	DWS Offset (in)	N/A
N/A	Shared Landing?	N/A			
N/A	Gutter Ponding?	Yes	N/A	Gutter Slope (%)	N/A
N/A	Gutter Lip Ht (in)	N/A	N/A	Gutter X Slope (%)	N/A
N/A	Painted X Walk1?	Yes	N/A	Painted X Walk2?	No
	X Walk 1 Direction	To SW		X Walk 2 Direction	To SE
N/A	X Walk 1 Width (in)	77.0	N/A	X Walk 2 Width (in)	N/A
	X Walk 1 Slope (%)	6.7		X Walk 2 Slope (%)	0.6
	X Walk 1 X Slope (%)	1.3		X Walk 2 X Slope (%)	5.0

N/A	Ramp inside XWalk1?	Yes	N/A	Ramp inside XWalk2?	N/A
	Road Slope (%)	1.6	N/A	Clear Space?	N/A
	Road X Slope (%)	5.6	N/A	Clear Space to XWalk (in)	N/A
N/A	Any Obstructions?	N/A	N/A	Storm Grate/Utility Hazard?	N/A
	Obstruction Type			Storm Grate/Utility Type	
		N/A			N/A
		Yes		Surface Condition? (G/P)	Good

Possible Solutions:

Remove & Replace Curb Ramp With Two New Directional Ramps or Equivalent.
