Access Compliance Report

Public Rights-of-Way (Curb Ramps)

Intersection ID: 23825	Main Street: LOBLOLLY_LN	Cross Street: LONGLEAF_DR	Location: SW
ADA ID: C5B119B67895	Ramp Type: Directional1	Initial Pass/Fail: Fail	Overall Compliance: No
		Severity Score: 12.5

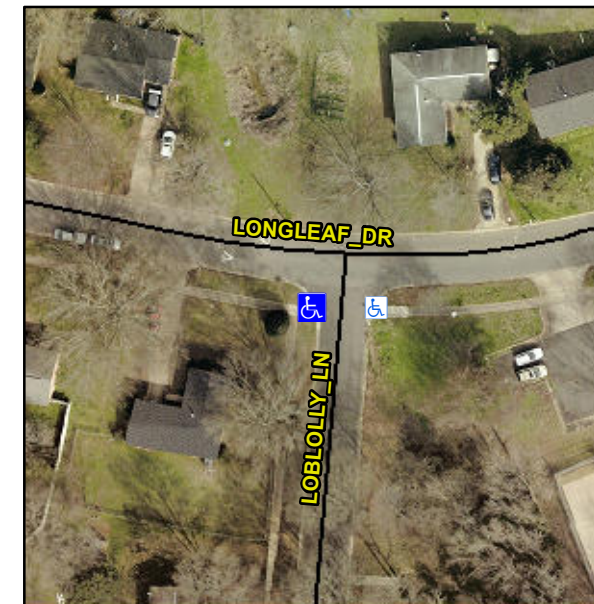
Compliance	Description	Data	Compliance	Description	Data
N/A	Ramp Length (in)	99.0	N/A	Grade Break?	N/A
Yes	Ramp Width (in)	57.0	N/A	Grade Break Slope (%)	0.0
No	Ramp Slope (%)	9.5	N/A	Grade Break XSlope (%)	0.0
Yes	Ramp XSlope (%)	1.9			
N/A	Flare Type LT	N/A	N/A	Flare Type RT	N/A
N/A	Flare Slope LT (%)	N/A	N/A	Flare Slope RT (%)	0.0
N/A	Flare Traversable LT?	N/A	N/A	Flare Traversable RT?	N/A
N/A	Landing Length (in)	0.0	N/A	DWS Provided?	N/A
N/A	Landing Width (in)	0.0	N/A	DWS Contrast?	N/A
N/A	Landing Slope (%)	0.0	N/A	DWS Length (in)	N/A
N/A	Landing X Slope (%)	0.0	N/A	DWS Full Width?	N/A
N/A	Landing Curb? (Y/N)	N/A	N/A	DWS Offset LT (in)	N/A
N/A	Shared Landing?	N/A	N/A	DWS Offset RT (in)	N/A
N/A	Gutter Ponding?	0.0	N/A	Gutter Slope (%)	N/A
N/A	Gutter Lip Ht (in)	0.0	N/A	Gutter X Slope (%)	N/A
N/A	Painted X Walk1?	No		Road Slope (%)	5.9
	X Walk 1 Direction	To E		Road X Slope (%)	4.2
	X Walk 1 Width (in)	N/A		Clear Space?	N/A

X Walk 1 Slope (%)	5.9	N/A	Clear Space to XWalk (in)	N/A
	X Walk 1 X Slope (%)	4.2	N/A	Storm Grate/Utility Hazard?	N/A
N/A	Ramp inside XWalk1?	N/A		Storm Grate/Utility Type	
N/A	Any Obstructions?	N/A			N/A
	Obstruction Type		Yes	Surface Condition? (G/P)	Good
			N/A	Curb Slope (%)	8.3

Possible Solutions:

Remove & Replace Entire Ramp.

R304.2.2
